Building 86

Building Code Evaluation for Building 86
Romberg Tiburon Center
Tiburon, CA 94920

Prepared on: August 3, 2015

Inspection Date: July 29, 2015

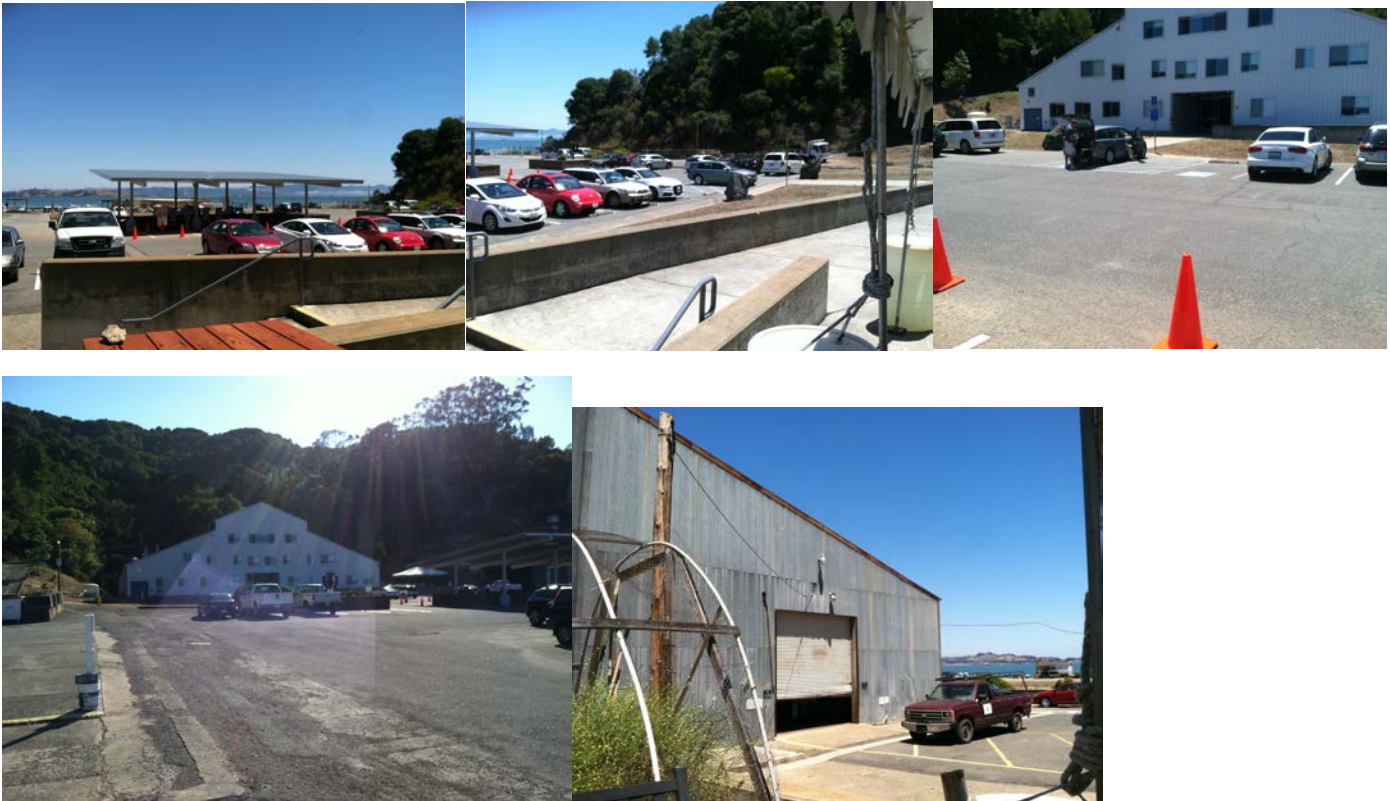
There is ample parking and a photovoltaic canopy. Currently, only one Van space is available and one car width space and no other ADA parking is demonstrated on site. Site lighting is unknown at this time. There are 2 dusk to dawn area lights on the south face of Building 86 (the subject of this review). There is no lighting on the west side of the structure and one area light on the north side of the structure above the roll up door. There is no discernable path of egress and no discernable front entrance. There are several exterior doors, three being roll-up style and 2 being man-doors: 1 single on North side and 1 double on the East side. The inspector performing this evaluation and report is not CASp Certified. This evaluation is not CASp equivalent. Any CASp required evaluation must be performed by a Certified CASp inspector.

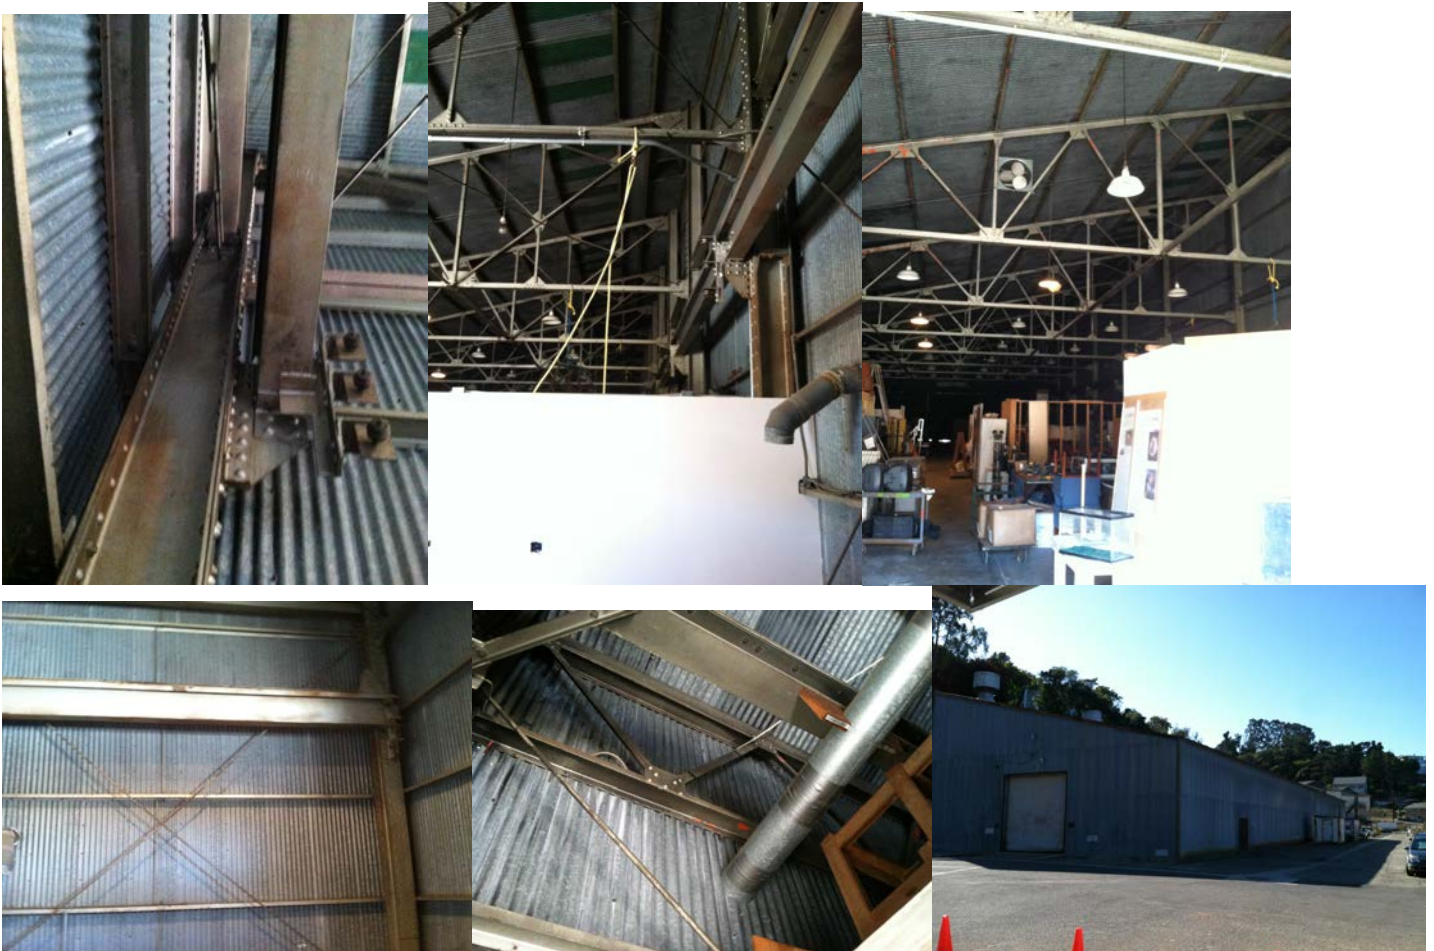
The structure is steel framed, corrugated steel exterior with metal corrugated roof with multiple layers and cap sheeting. It is 11,600 sqft single story. The roof is supported by an open metal truss system. The building can be defined as a Type III B non-combustible construction with a fire separation of 30' depending on the lot line of this structure. The foundation appears to be pier under column with a separate slab on grade. The roof is supported by an open truss system. There are also rod braces diagonally in each bay between the supporting columns. The style of the structure is shed roof framed metal building. There appears to be no modification to the original construction/design of the shell and support system of the structure. There is a bridge crane that spans the short span of the structure that runs the long length. Wind and seismic loads are handled by the rod system in each bay and by the longitudinal brace running the entire length of the building. The columns are bolted to the pier foundation.

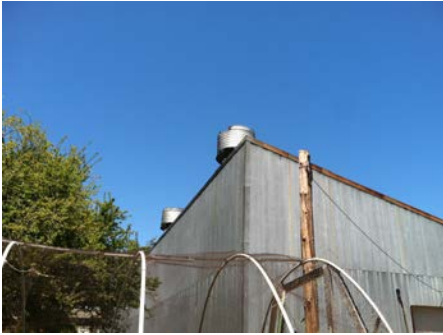
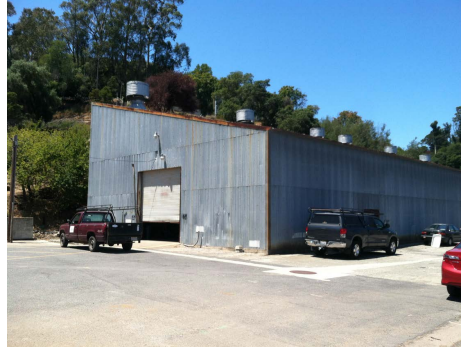
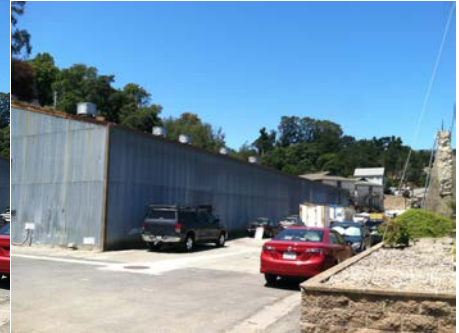
Building 86 shows signs of minimal exterior rust mostly located on the roof drip edge at perimeter of structure and along the bottom perimeter of the structure. There are multiple air handling units on the roof. They appear to be old exhaust fans, but are rusted, in some ways to the point of missing sections of metal. I cannot access the roof and as such, cannot verify if they are powered or if they operate. There is no gutter or downspouts and since it is a shed roof, there are no scuppers. The roof has been identified as a mixed-material roof. One of those materials is Plexiglas corrugated to match the existing corrugated metal roof. Information from others is that the roof has several layers and is potentially dangerous to access due to skylights being covered by the Plexiglas and imperceptible from roof top side.

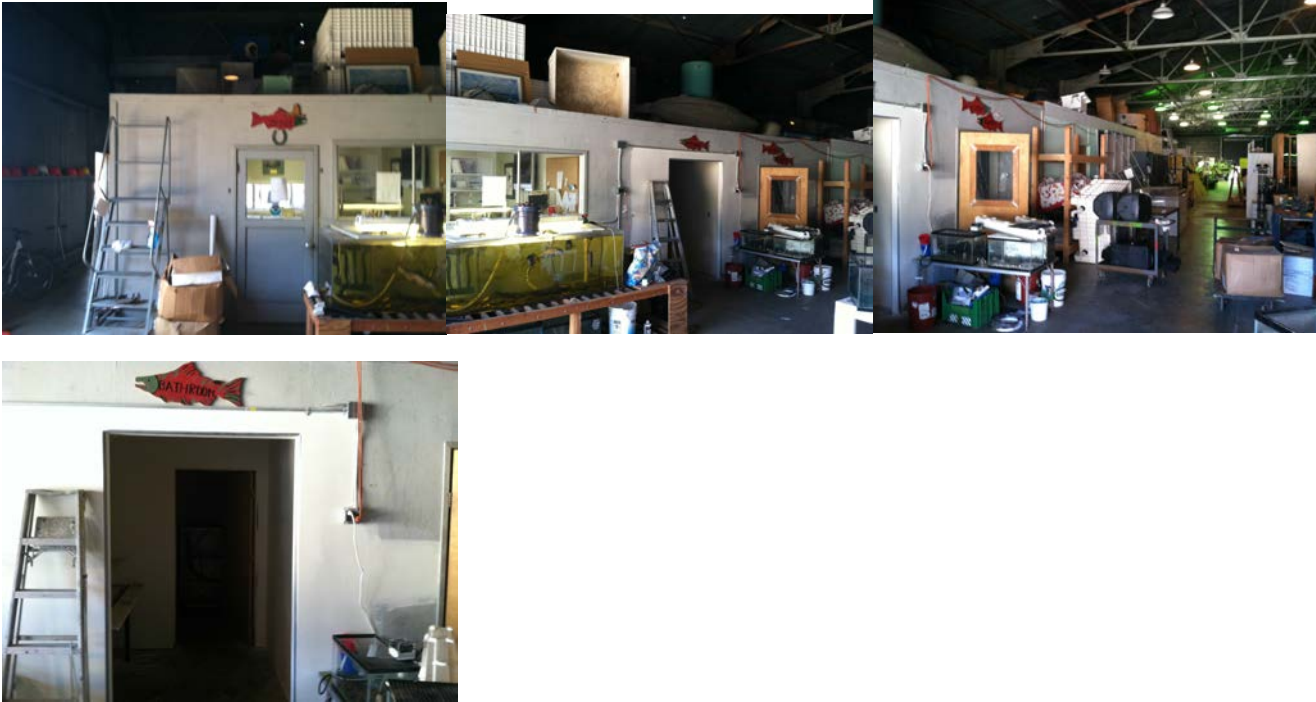
I entered on the north side of the structure through the rollup door located in the center of the building. To my left are existing offices with approximately 8'-10" to 9' high walls. Some walls are newly modified; specifically, door openings have been created. Above these offices is a mezzanine made up of the ceiling structure of the offices, being used as storage. There have been many electrical and plumbing additions noticed in these older offices. None of this work was observed during installation and cannot be verified as constructed correctly. The many issues raised by the new construction are addressed below.

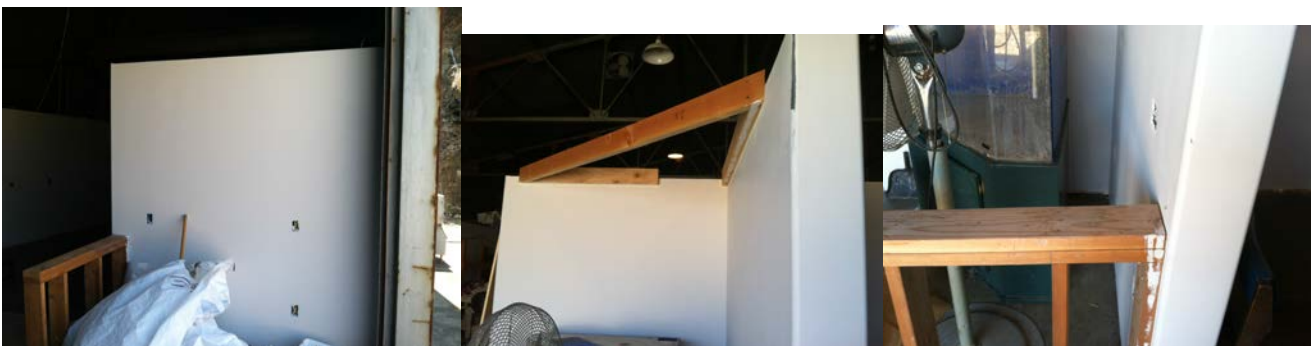
To my right as I enter from the north are new walls of unknown construction. They appear to be 2x6 with ½" sheetrock. Their insulation status is unknown. The walls are approximately 6-3/4" thick & 97-1/4" tall. These walls are unsupported and have no ceiling. These walls were not observed during construction and as such, I cannot determine or verify anchorage, nailing or material. The new wall construction creates a single room with a wood floor and an improperly installed electrical box in the center. There are many electrical boxes located through out the interior side and exterior side of these new walls. They are filled with conductors, are unidentified and not safed-off.

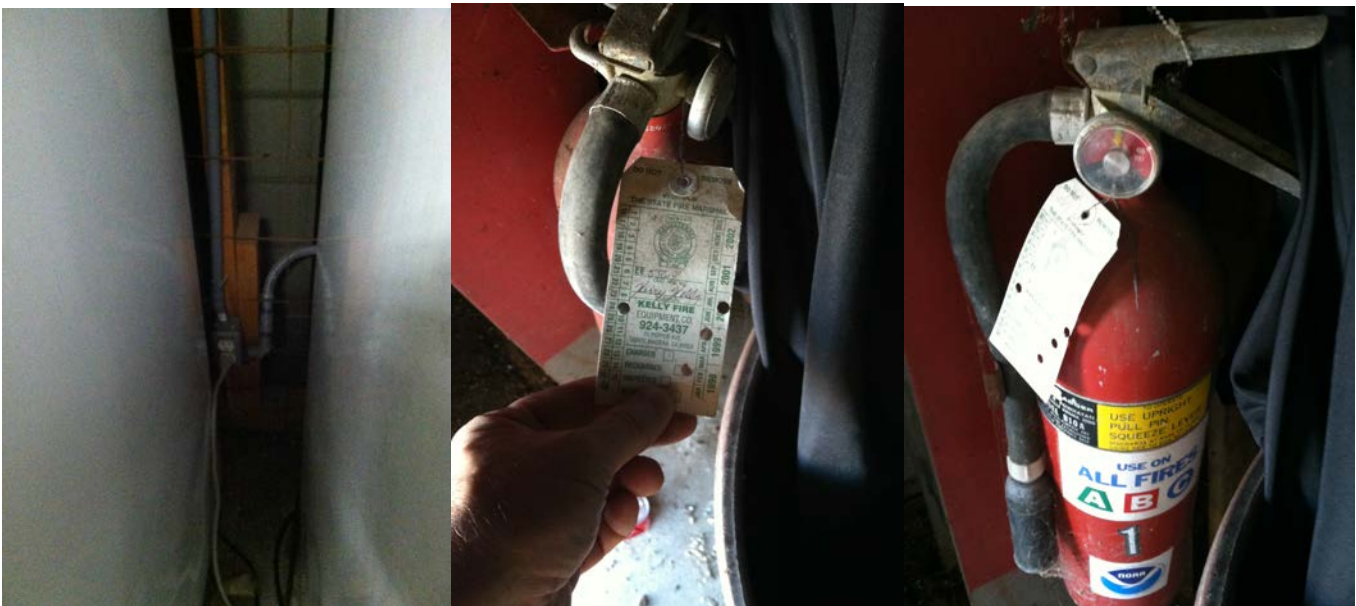
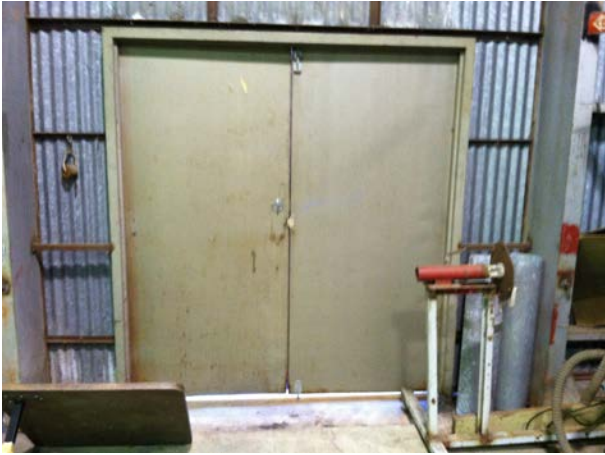
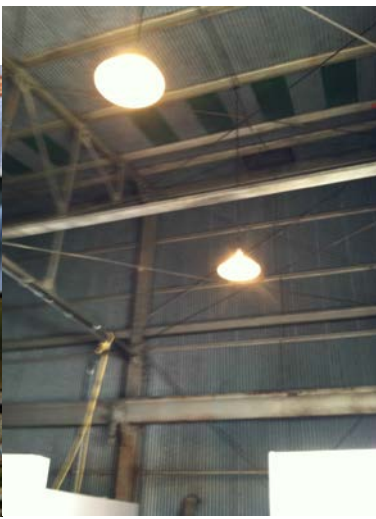
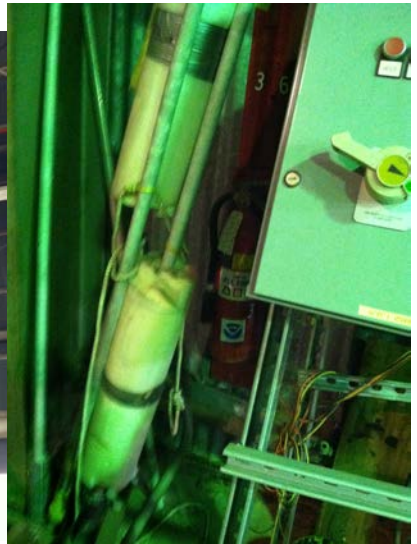
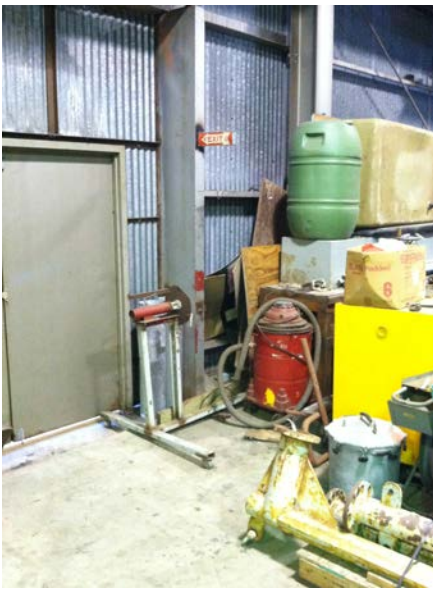
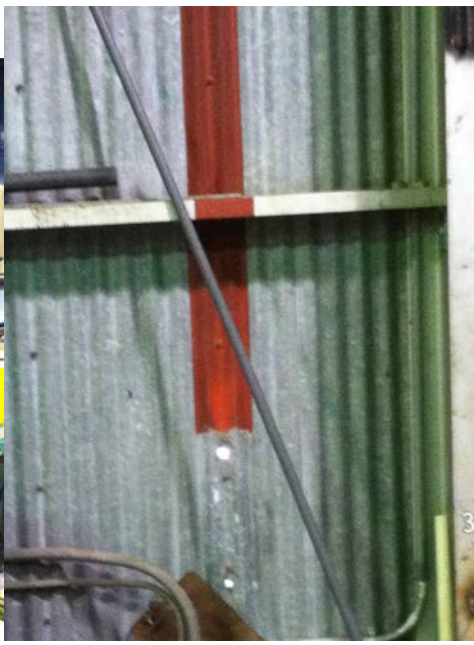
3. There is no standpipe and no fire sprinkler system in the structure. The size (area) of the structure is 11,600 sqft and as such falls in the limitation of type IIIB construction per Chapter 5 (General Building Heights and Areas) table 503B. Stacked storage above the offices shall be removed or the area above the office shall be considered in addition to the sqft of the warehouse, which may exceed the area limitation causing additional fire protection to be added. i.e. Sprinkler system. Section 903.2.9 (S-1 >12,000 requires sprinkler)

6. The fire extinguishers within the structure are not placed per code nor are they kept up-to-date. Section 906 of the CBC and CFC and Title 19 Public Safety Code CCR.

7. There are no illuminated or self-illuminated exit signs within the facility. They are required per 1104.3 Cal. Fire Code
8. Storage was placed thought the storage area without access to electrical panels or pathways for emergency exiting. Stored material must be stacked to allow isle pathways designed per section 1104.22 Cal. Fire Code.

9. Flammable and combustible liquids must be stored according to Chapter 57 of the Cal Fire code or removed from site, if any.
10. Lighting is insufficient per CBC section 1006, et al to include no emergency lighting and insufficient lighting.

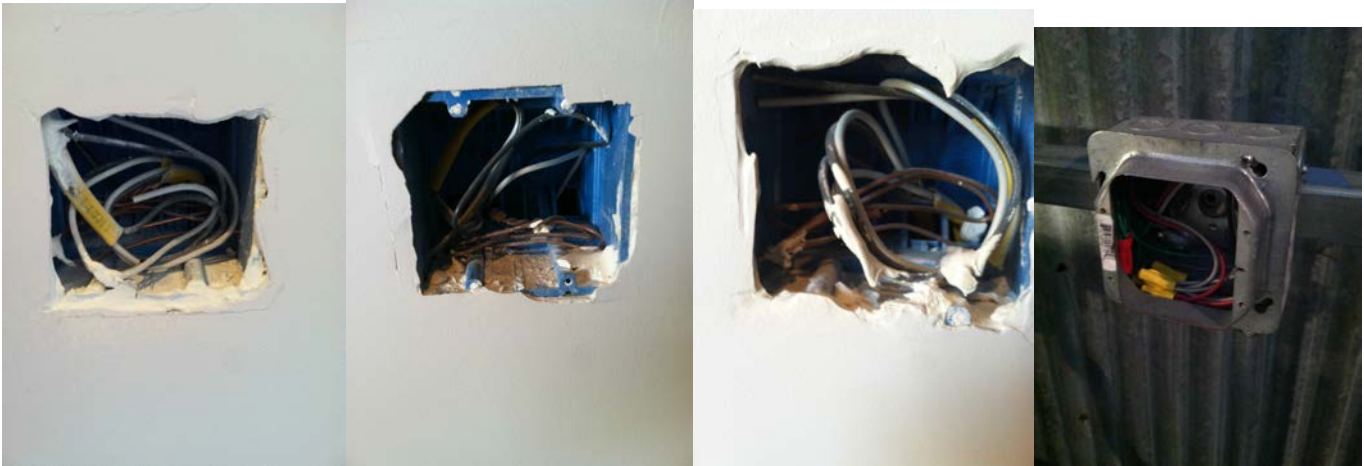
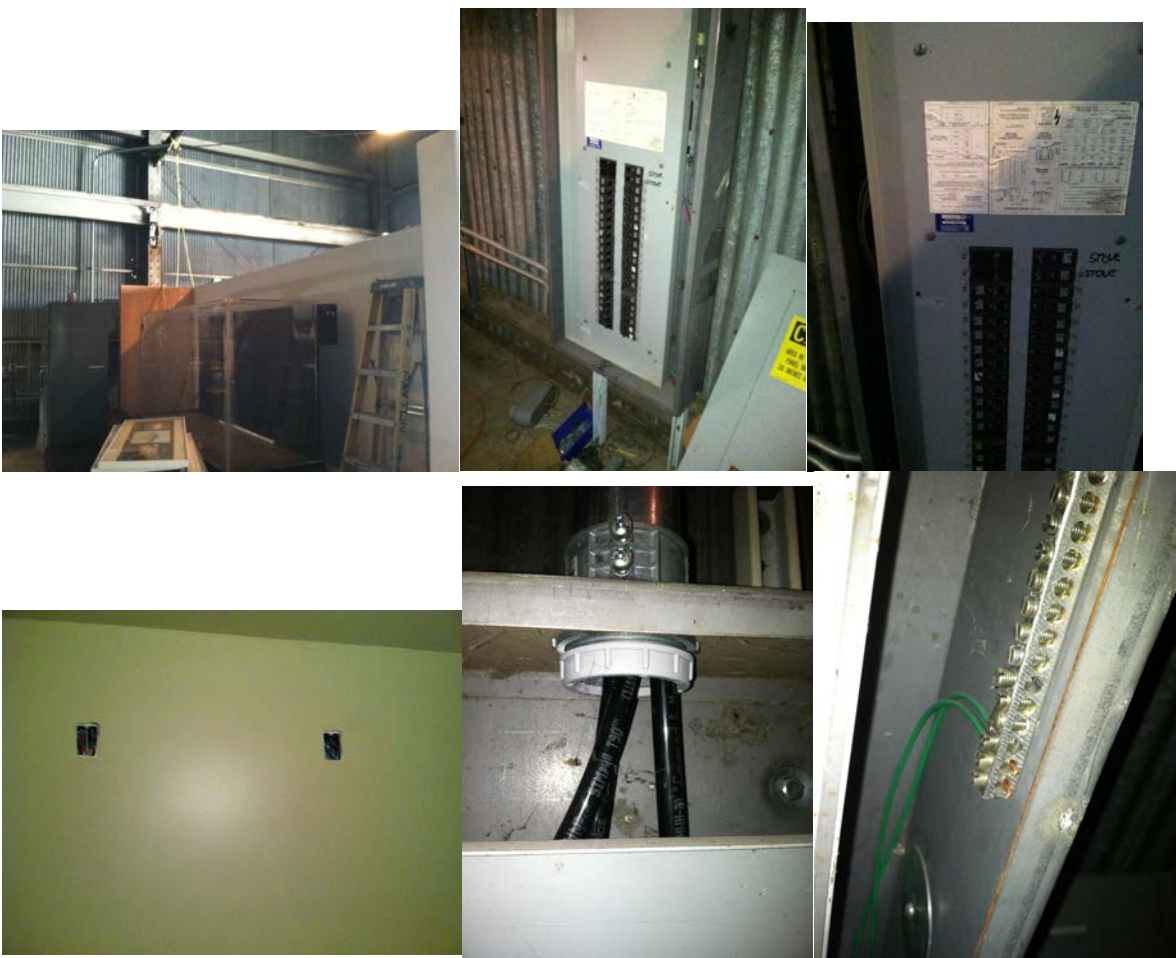
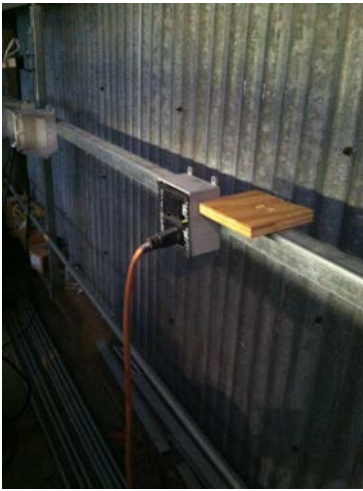
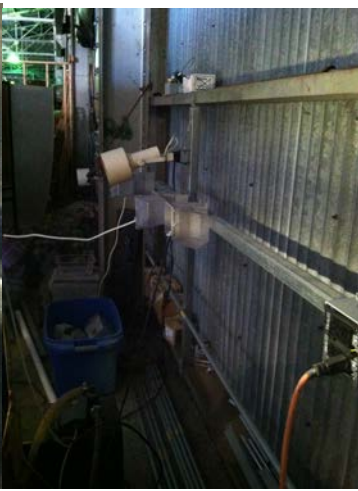
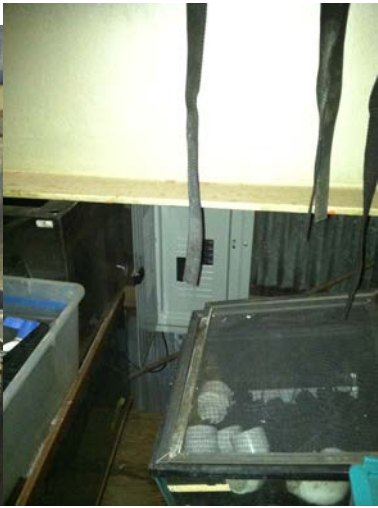
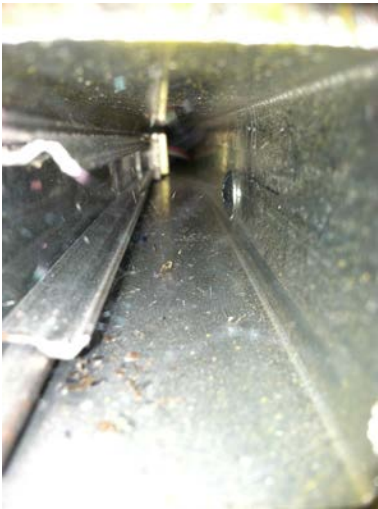
1. Junction boxes are unsafe/not safed off. 110.27
2. There are multiple electrical panels around the structure. One such panel is located to the right just past the newly constructed walls on the west wall exterior see picture. This panel seems to be a sub distribution panel pulling electricity from a newly installed main distribution panel above the existing office space. This panel is not properly bonded or grounded, article 250 et al,

3. is open to access, 110.27
4. does not have sufficient clearance 110.26 and
5. is installed upside down 110.12.
6. The MAIN panel newly installed is unidentifiable due to access limitations, 110.26 and

7. I cannot verify proper grounding and bonding. 110.8 , 210.3, 210.8, 250, et al.
8. Neither panel is labelled properly. 110.3
9. These panels do not meet the clearance requirements around the panel. 110.26

10. Front not installed or open breaker location-110.27
11. There are multiple junction boxes throughout the facility that are open exposing wires. 110.27

12. Electrical boxes are improperly supported or unsupported completely. 110.13
13. Existing electrical system has no ground and is not properly bonded Article 200.3, 250, et al.

14. Contractor install PVC conduit on interior walls and ceilings accessible and available for damage.
15. Electrical circuits may be overloaded with too many outlets on one circuit. 210.6, 210.11, 210.19

Code References violated by the electrical installation are multiple. Many violations identified have multiple codes that can be referenced in the same location. Below is a narrative of some issues that are in violation of the Cal Electrical Code. A summary of the defects indicates that the system should be removed, designed by an electrical engineer, installed with proper wire size and installation requirements, and said design is to include the interface with existing ungrounded electrical systems that demonstrate aged deterioration, insufficiency of installation and potential failure.

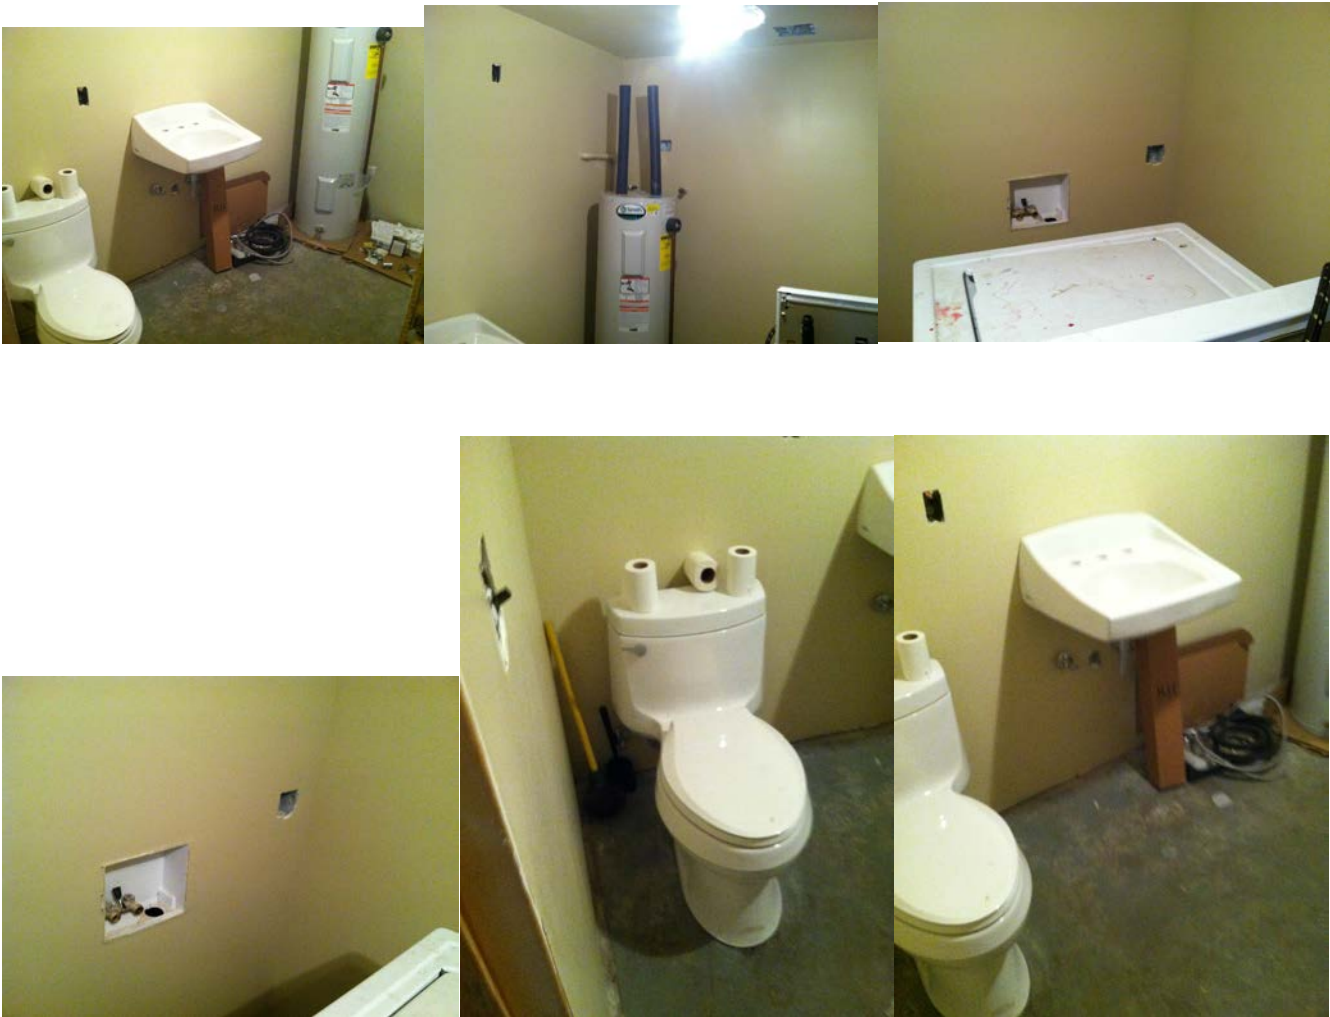
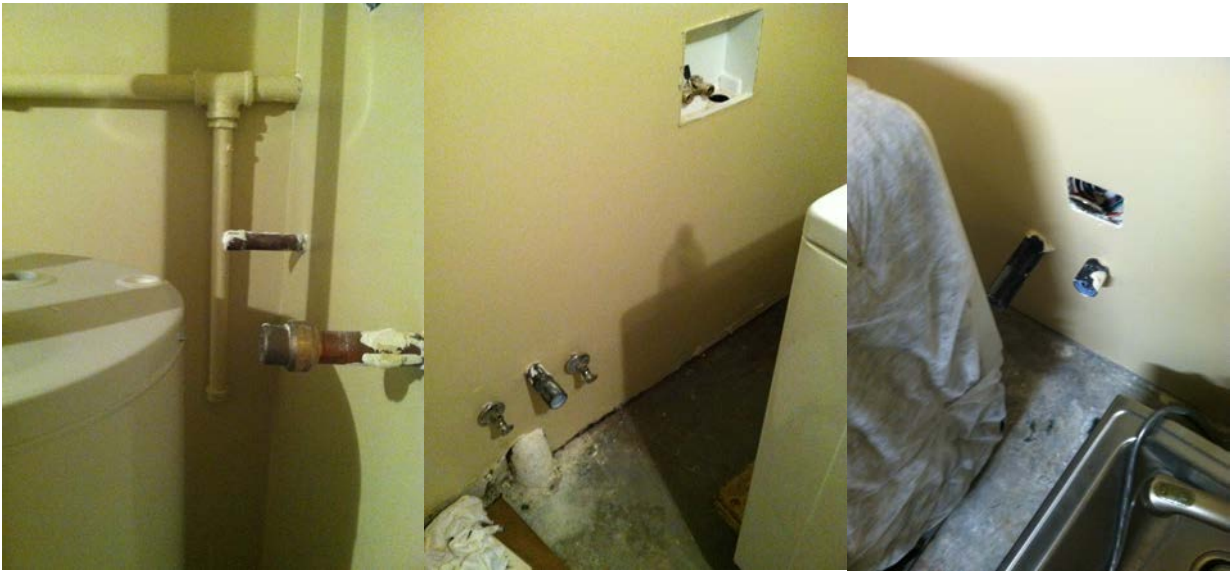
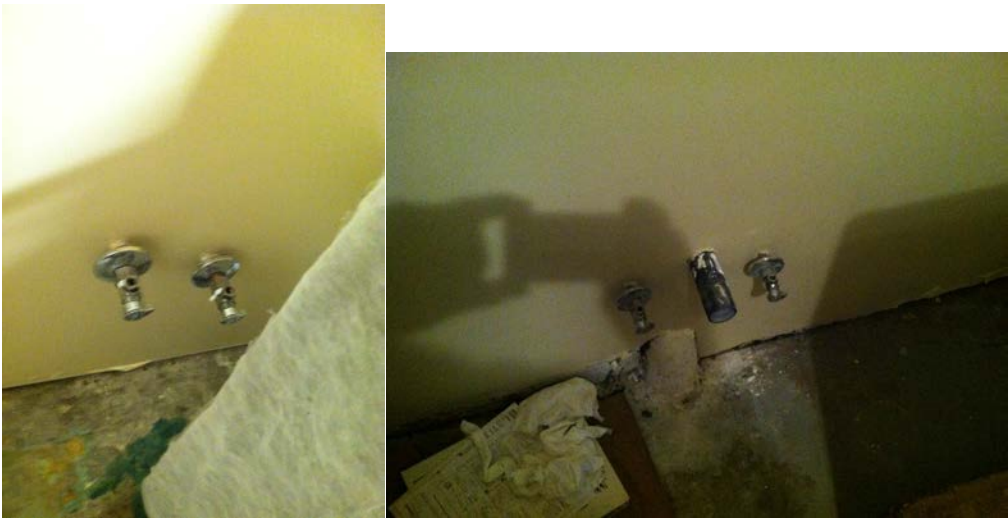
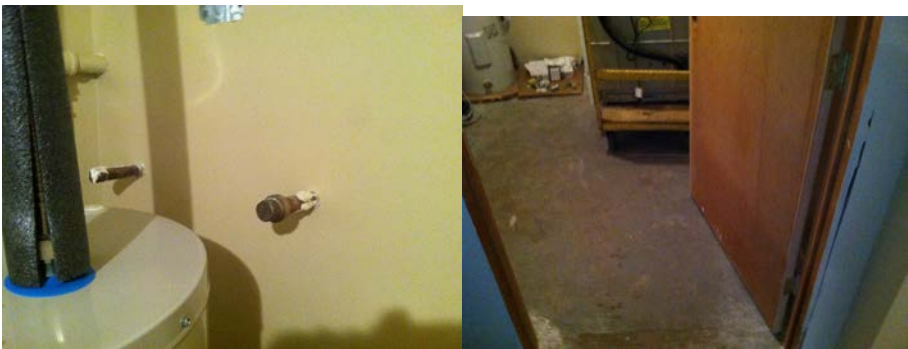
Someone began creating a bathroom on the left-hand side as I entered from the north.

1. The bathroom has no clean out. Cal Plumbing Code 707
2. The domestic water, waste and vent are unverified. Chapter 1 Cal Plumbing Code
3. The exhaust fan is not vented through the roof or to the exterior of the structure.
4. A hot water heater is being installed and the installation stopped. The hot water heater is to be installed per Chapter 5 of the Cal Plumbing Code.
5. Toilet is not Ch 11B CBC compliant in location, height or grab bars
6. Sink does not meet Ch 11B CBC

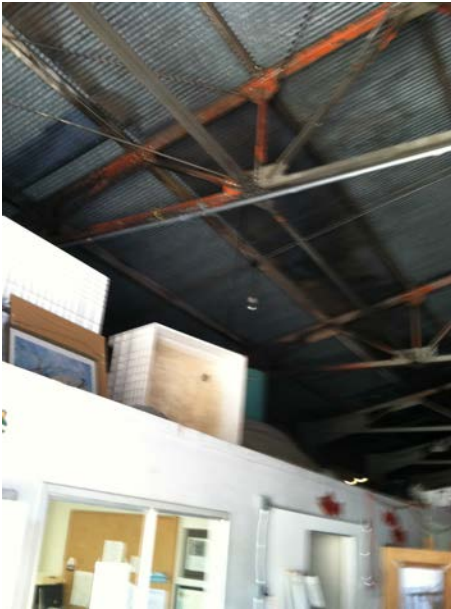
Currently the storage on the floor does not constitute "High Piled Combustible Storage" as defined in Cal Fire Code Chapter 32, however, continued use of the mezzanine above the offices as storage could be construed to meet the standards, especially based on the nature of the material stored. Further, the storage above the offices is not accessible (does not meet Ch11B) and there is no means of egress that complies with chapter 10 of the CBC. Until the mezzanine meets all the code requirements, the area should not be used for storage.
