August 3, 2015

Subject: Preliminary Hazards Material Observations  
Building 86  
Romberg Tiburon Center (RTC) for Environmental Studies  
San Francisco State University  
3150 Paradise Drive, Tiburon, CA 94920  
PSI Project No. 0582

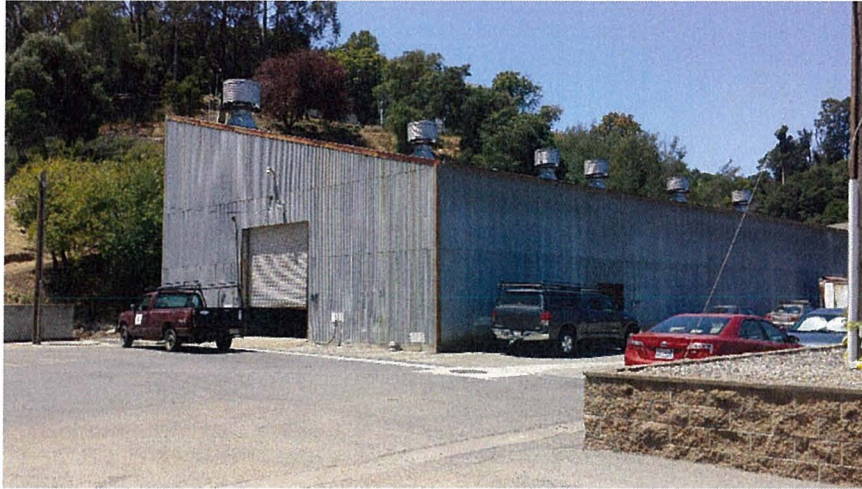
General outside view of Bldg. 86

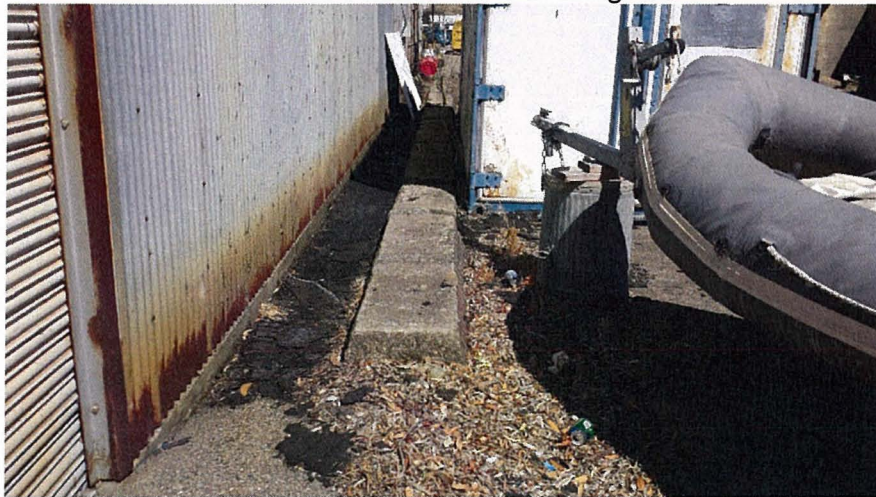
PSI collected four (4) samples of roofing debris from the ground around the building. Analysis of the samples was performed at Micro Analytical Laboratory located in Emeryville, CA, in accordance with the EPA Standard Method for Determination of Asbestos in Bulk Building Materials (EPA / 600/R-93/116 July 1993). Asbestos was not detected in any of the sampled

Although the debris samples were found not to contain asbestos, additional evaluation of the roofing system would be required to verify the number of layers, as well as the use of flashing or associated penetration mastics. Drywall texture and joint compound associated with the order office area, as well as exterior window caulking should be assumed to contain asbestos until it can be properly sampled and characterized.

Roof Membrane Debris along West Wall of Building

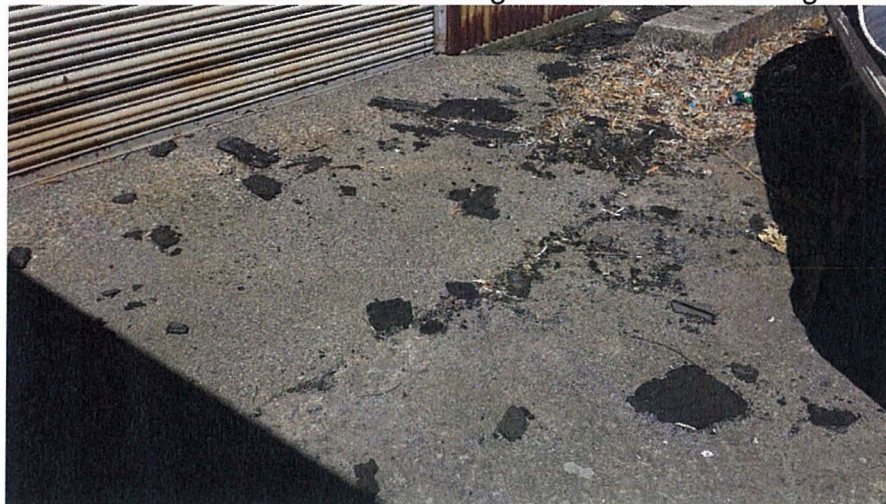
Roof Membrane Debris along West Wall of Building

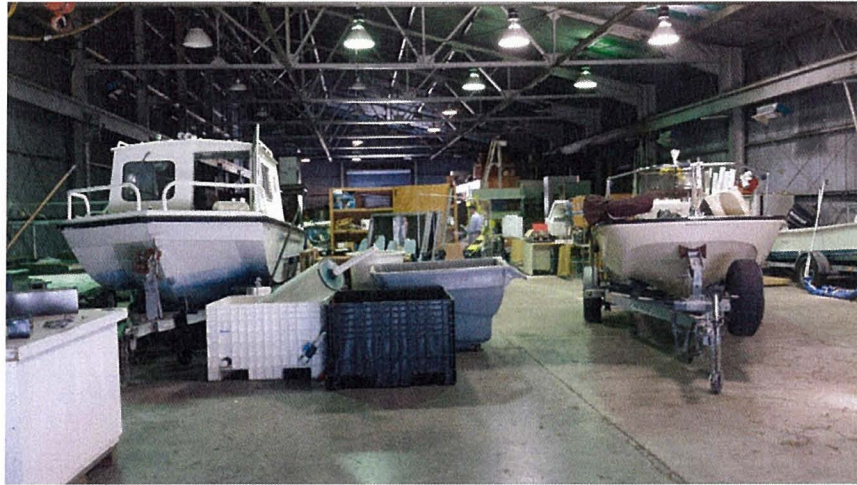
Contents within the open areas of the warehouse were filled with a variety of equipment, salvage display/aquarium items, furniture, tools and marine testing equipment. The contents did not appear to be organized and the warehouse area was generally disheveled in appearance.

General view of Warehouse area

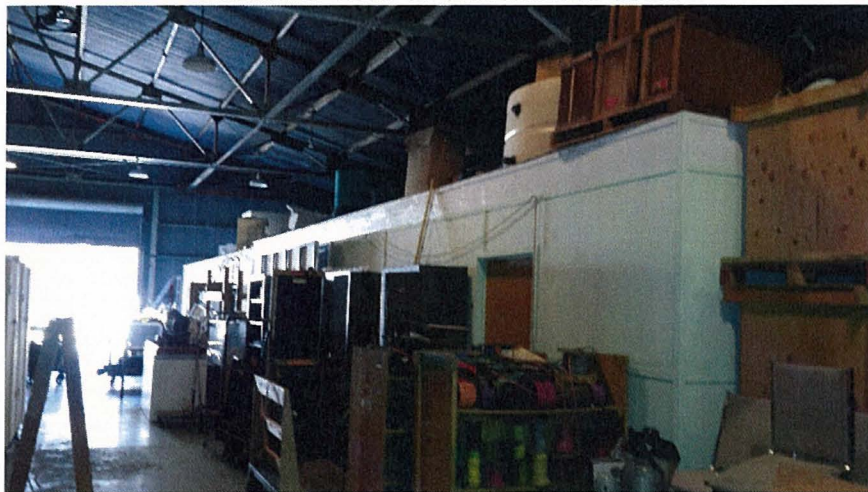
Storage on top of Office Area

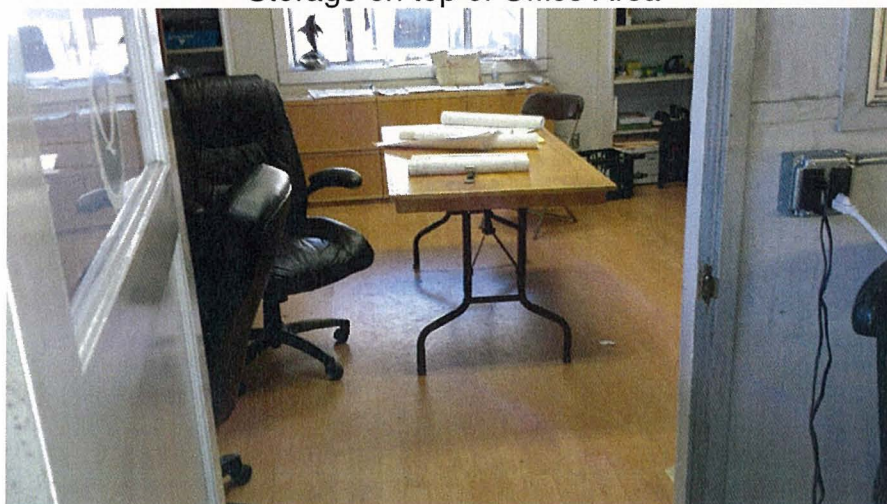
Office interior and warehouse facing finishes

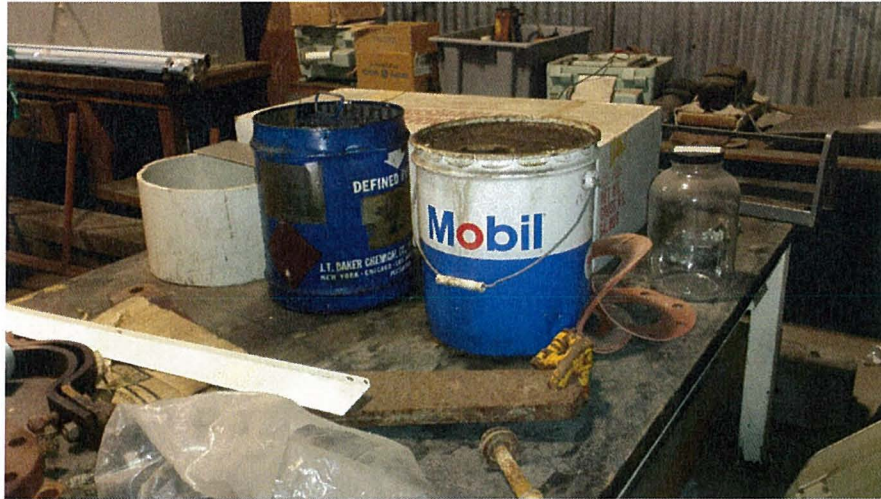
Storage of Oil related products

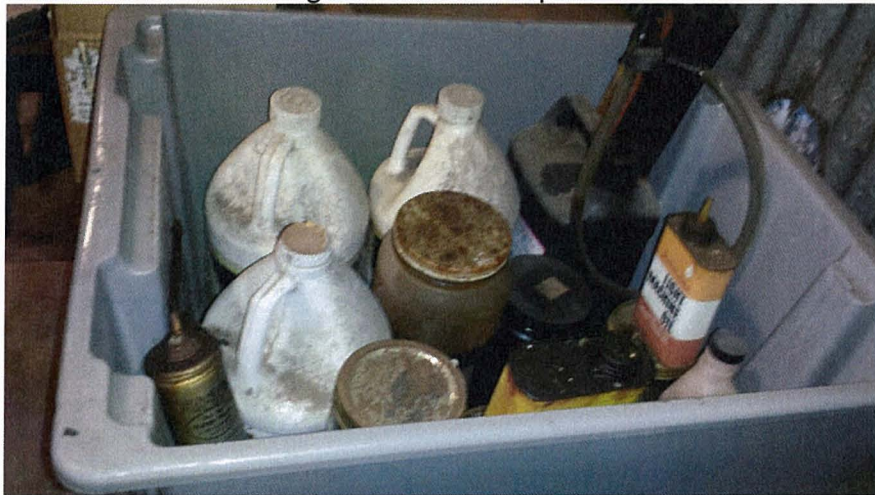
Storage of Cleaners and Lubrication Oils

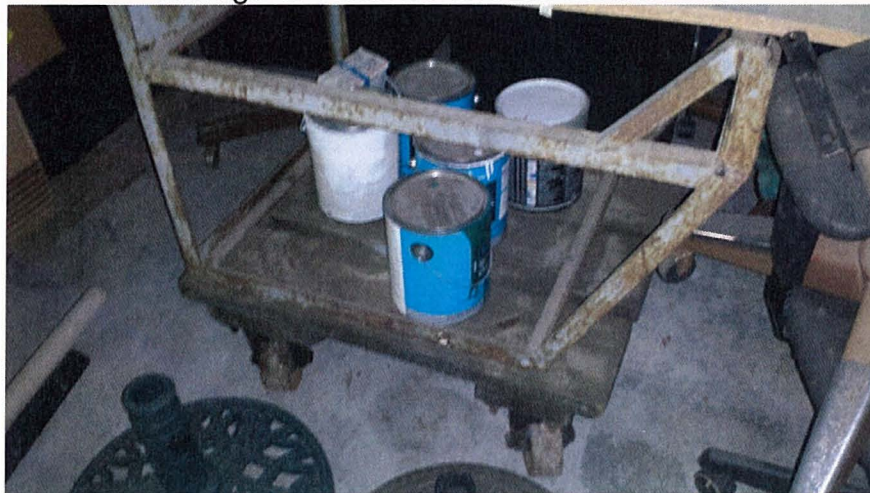
Storage of Used Paint Cans

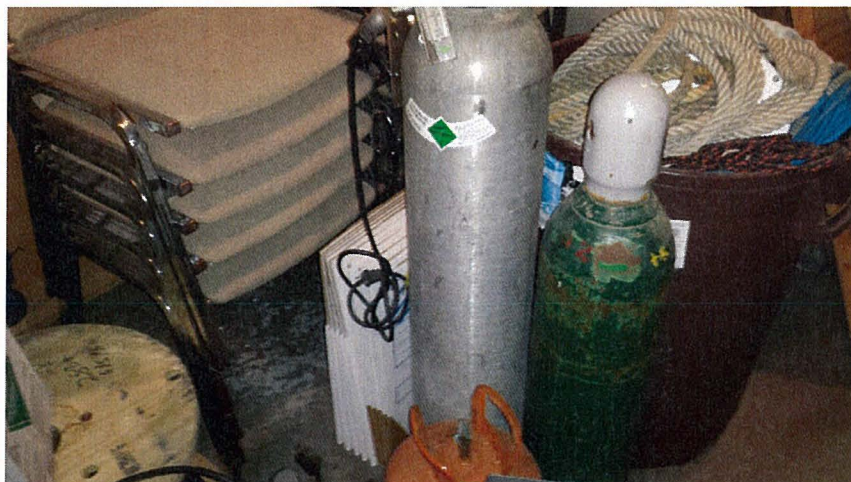
In addition to oils, cleaners and lubricants, PSI noted several compressed gas cylinder in the warehouse. Cylinders noted included Carbon Dioxide, Oxygen Oxy-Acetylene welding, propane and some unmarked tanks likely associated with scuba diving. In most cases, the cylinders did not appeared to be chained or otherwise secured from failing. In one case, the valve portion of what appeared to be a loose scuba tank had rolled beneath the leg of a rolling stair tower, possibly subject to breakage. PSI also noted one storage box labeled as containing human blood. Although it is likely that this box was a salvaged cooler, confirmation of contents and correction of the label should be performed. Although not directly related to hazardous materials, PSI did note several fire extinguishers in the warehouse area that were either out of

Unsecured Carbon Dioxide, Oxygen and unknown Orange Gas Cylinders

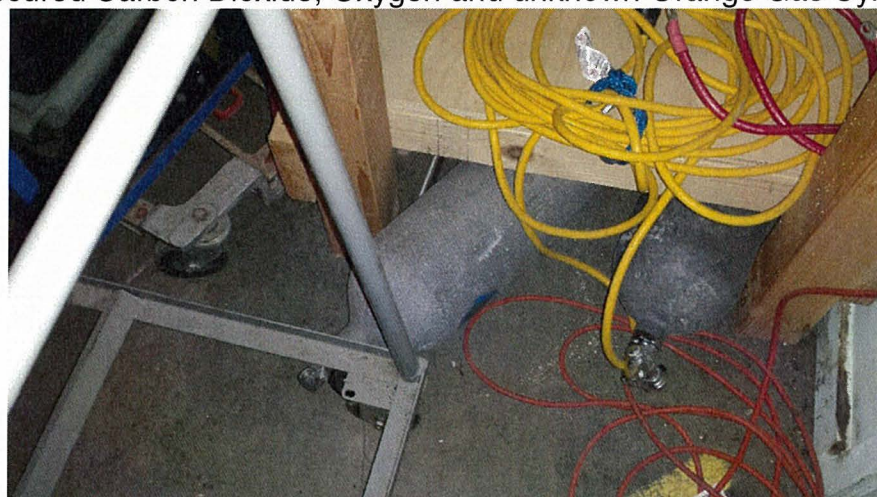
Suspect loose Scuba Tank valve beneath portable stair tower

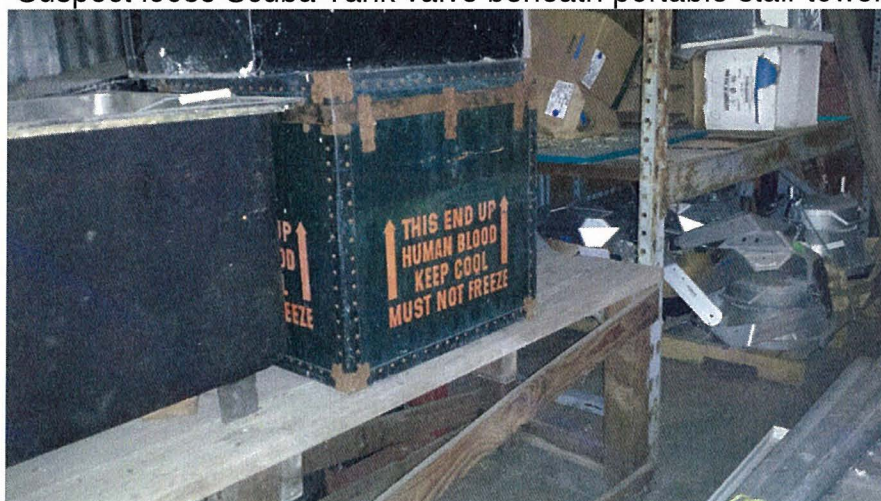
Storage Box Labeled "Human Blood"

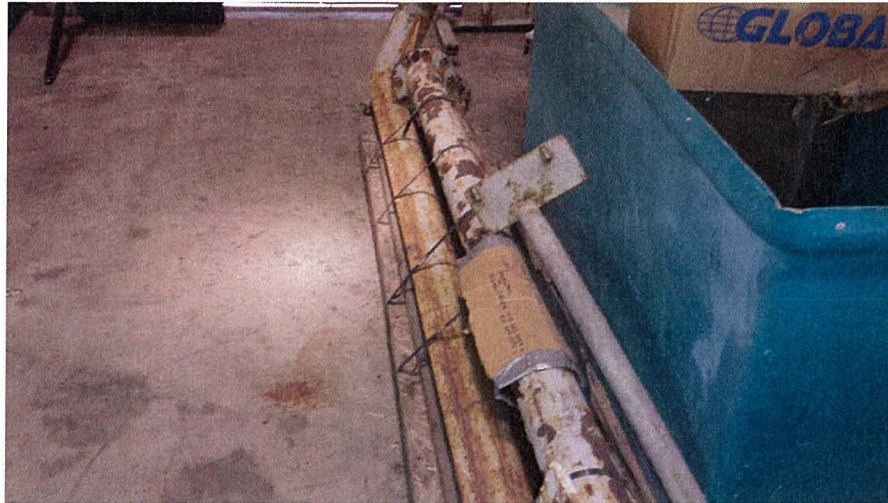
Based on the age of the building, all paints and coatings are required by regulation to be assumed to be LBP. During the site visit, the corrugated metal siding of Building 86 was not painted, however framing, interior office areas were painted. Paint associated with metal framing was in fair overall condition with some blistering noted on some roof framing and on metal roll up door framing. In addition, some painted metal piping was stored in the warehouse near the Northwest end that was noted as having paint in poor overall condition.

Stored Metal Pipes with Deteriorating Paint.

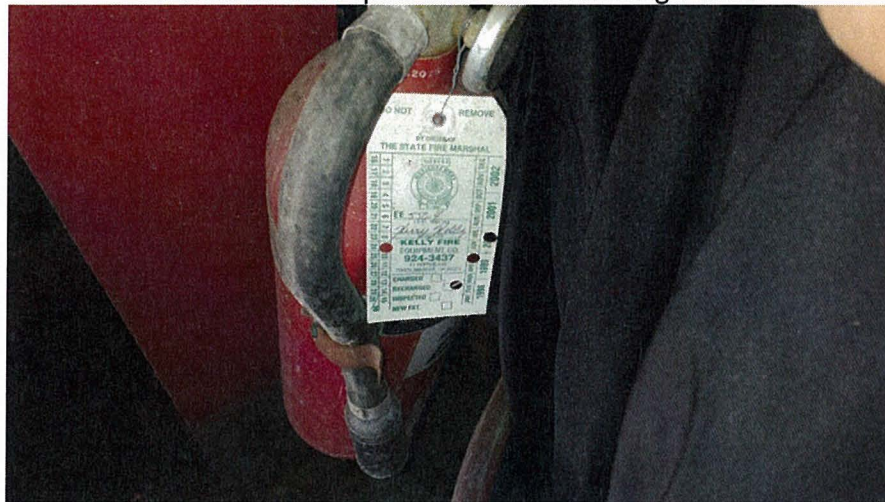
Fire Extinguisher, out of date (2000) and improperly stored
