## SAN FRANCISCO STATE UNIVERSITY

### MEMORANDUM

SUBJECT: TSI Safety Assessment at RTC

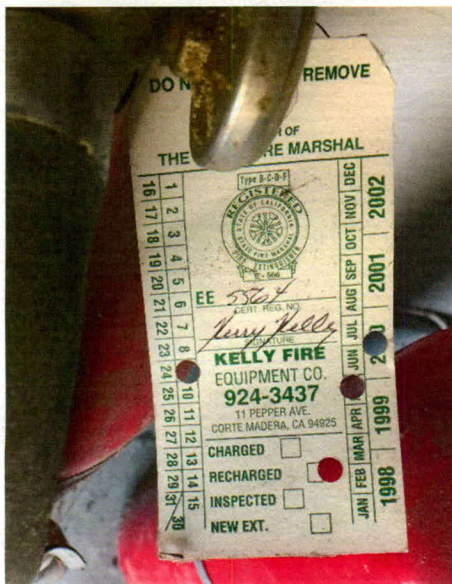
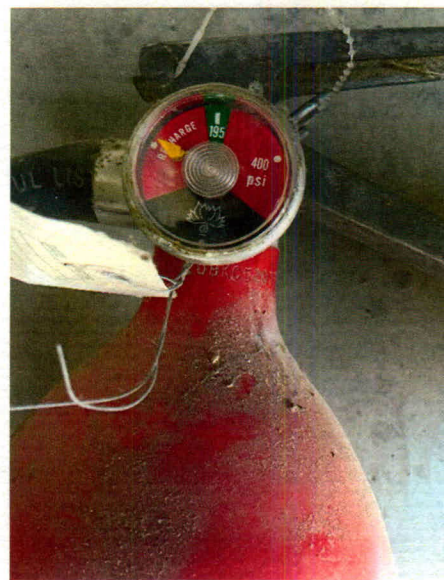
There are several fire extinguishers in the facility. None observed were certified within the past decade. None were properly mounted. Access to most was obstructed. No signage showing the location of the extinguishers was present. One fire extinguisher was observed to be out of pressure according to its gauge. (See photos 1 and 2).

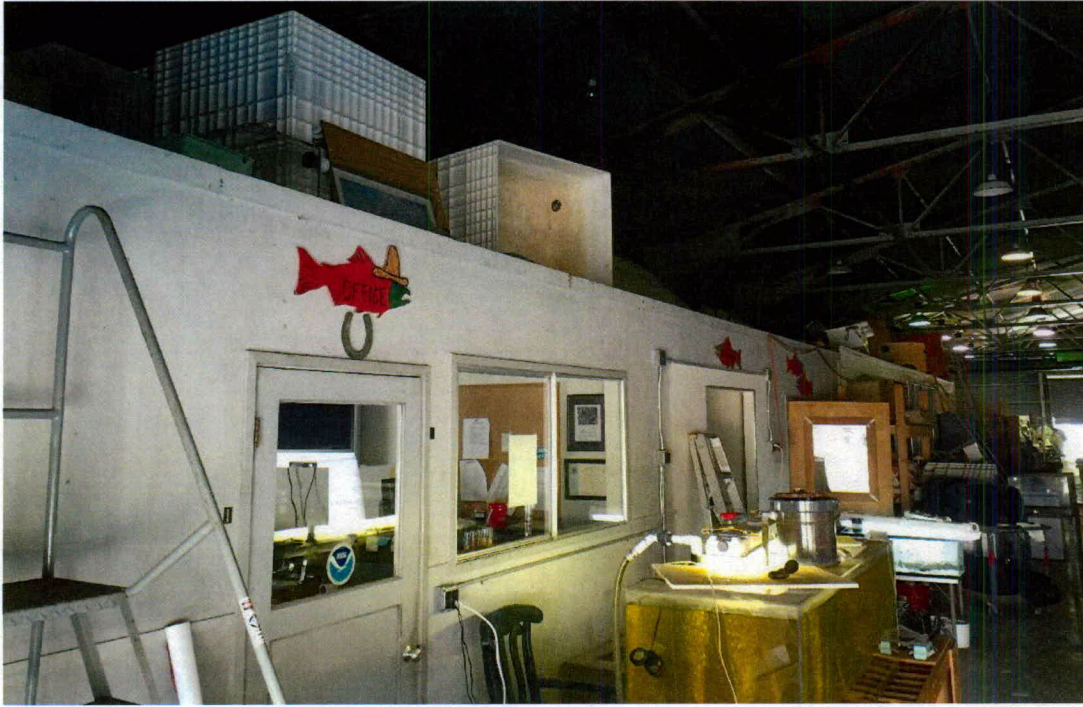
3

There was no indication of the load bearing limit for storage above the offices. Storage limits may be exceeded. This presents a hazard of collapse of the office roof. Leaking rainwater, if it lands on the office roof area may serve to reduce the weight bearing capacity of the roof. (See photo 3).

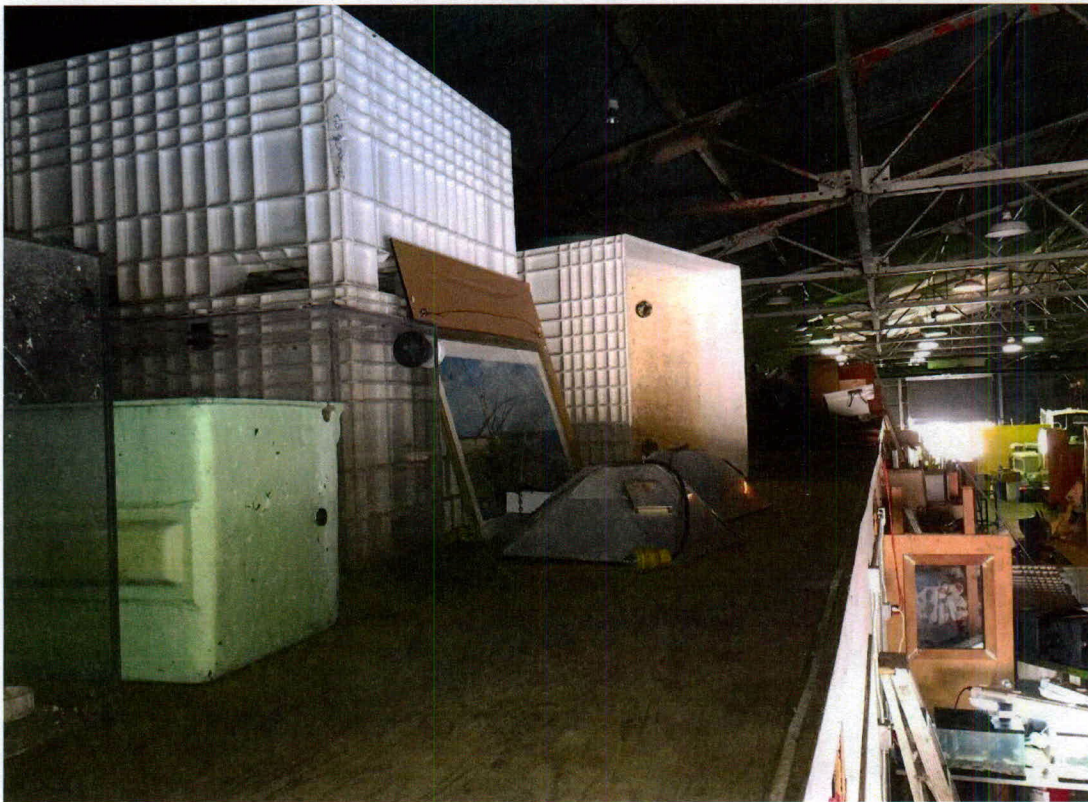
4

There is no railing or toeboards at the edge of the storage area above the offices. This presents a fall hazard, and a hazard from falling materials. (See Photo 4).

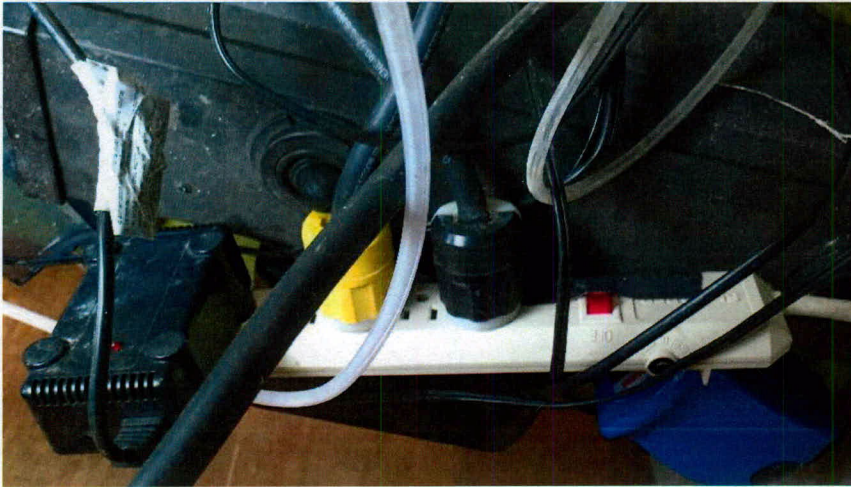
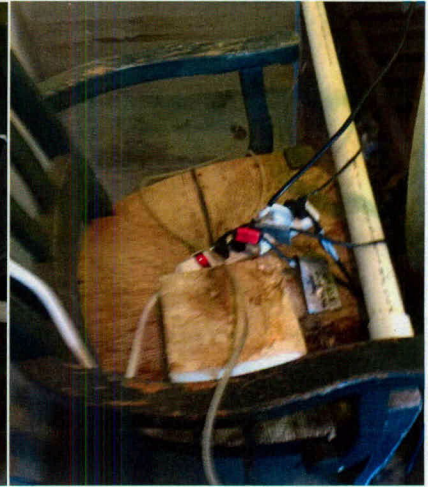
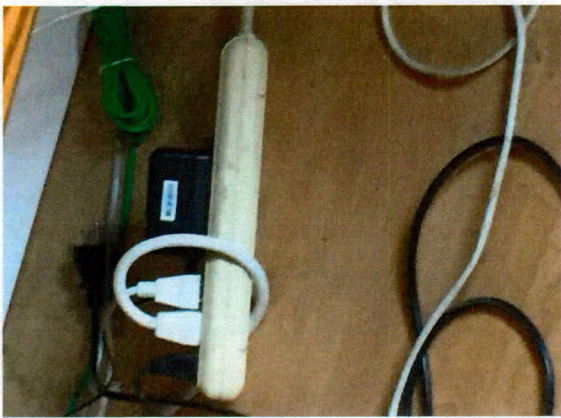
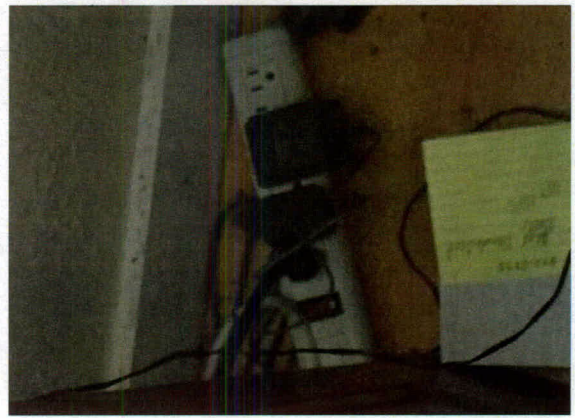
Throughout the building there are jury-rigged sets of daisy-chained extension cords. This presents an electrical safety and fire hazard. (See photos 5-8).

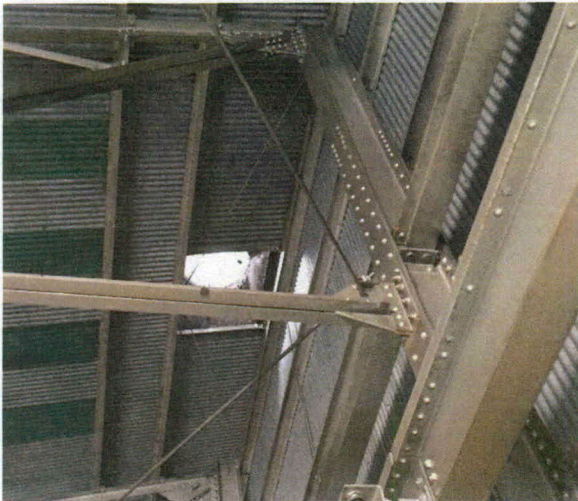
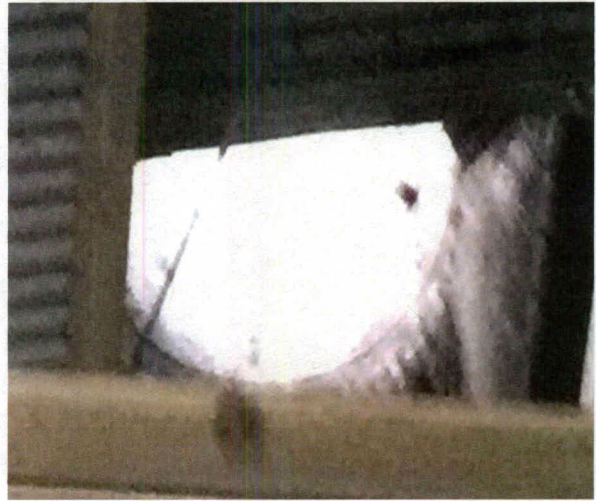
The roof will leak during rains which can enter horizontally through large openings in the numerous ventilator shafts on the roof. (See photos 9-10). Since the electrical supply supporting the lights and fish tanks must run continuously, the leaking rainwater creates a potential electrical and fire hazard if it comes in contact with energized electrical circuits. Additionally, the fish in the tanks would not last long w/o aeration, circulation etc.

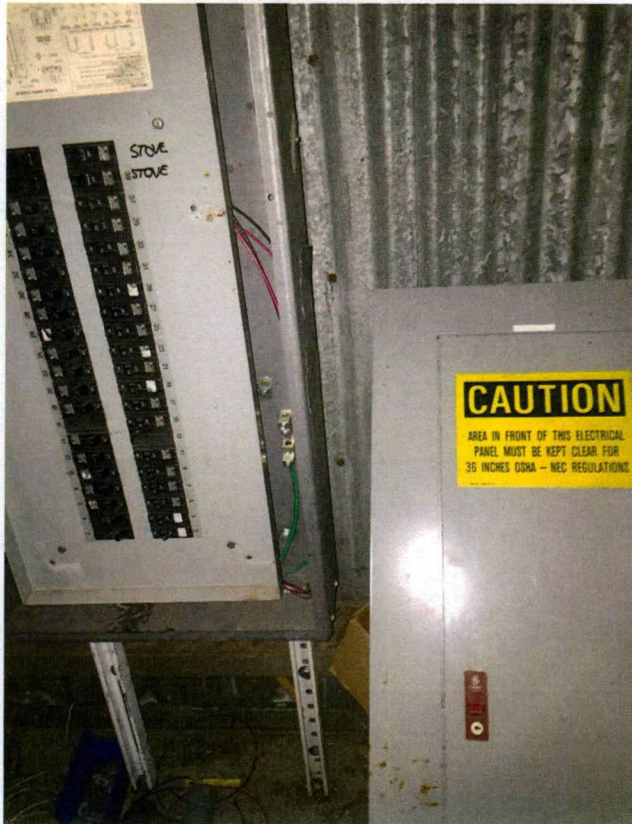
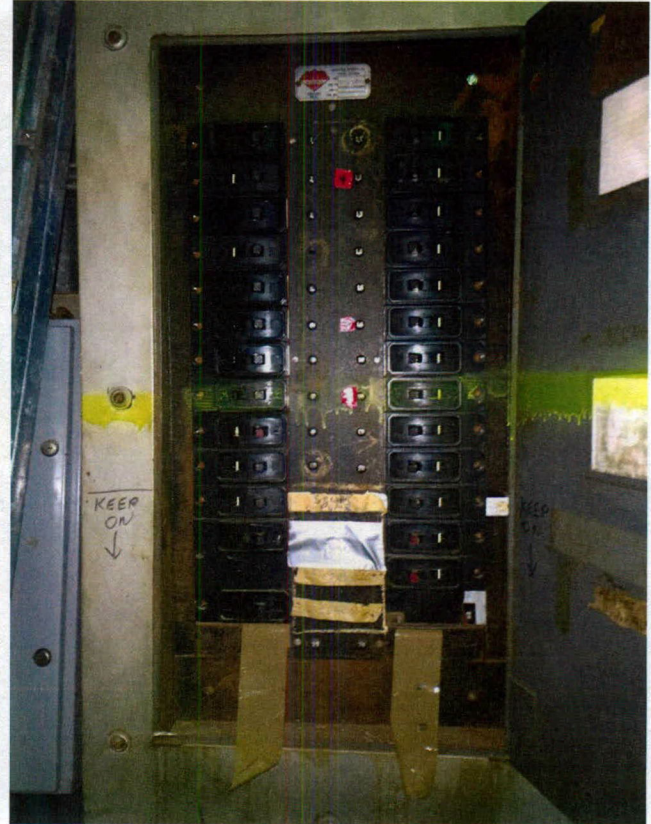
Two of the electrical panels were missing blanks used to cover openings left by removed circuit breakers. Accidentally reaching into the opening could lead to a fatal electrocution. This is an electrical safety hazard and Cal OSHA Violation. (See photos 11-12).

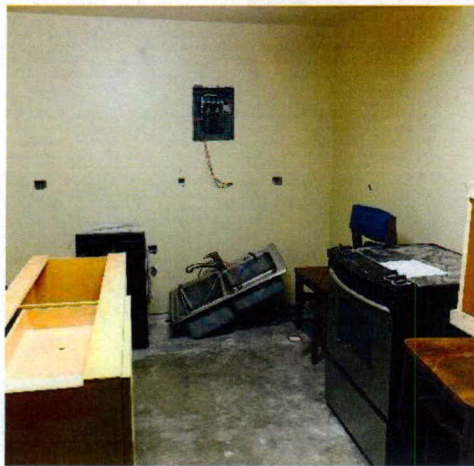
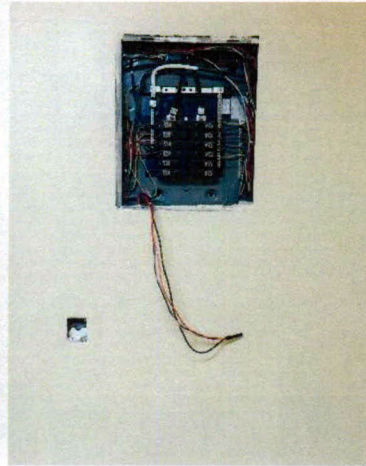
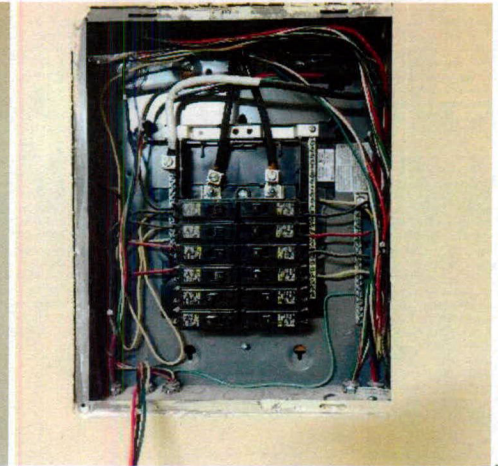
The electrical panel in one of the new construction areas was located in a large opening of the wall with direct access to the back of the electrical panel and live wiring. This would be allowable if current to the panel was locked out, but the wall switch in the room controlling the room's lighting was live. Contact with any of the exposed wiring on the panel could lead to a fatal electrocution. (See photos 13-15).

This is an electrical safety hazard, and more than one Cal OSHA violation. In addition there are numerous open electrical boxes with wiring present. It is not known if any were live.

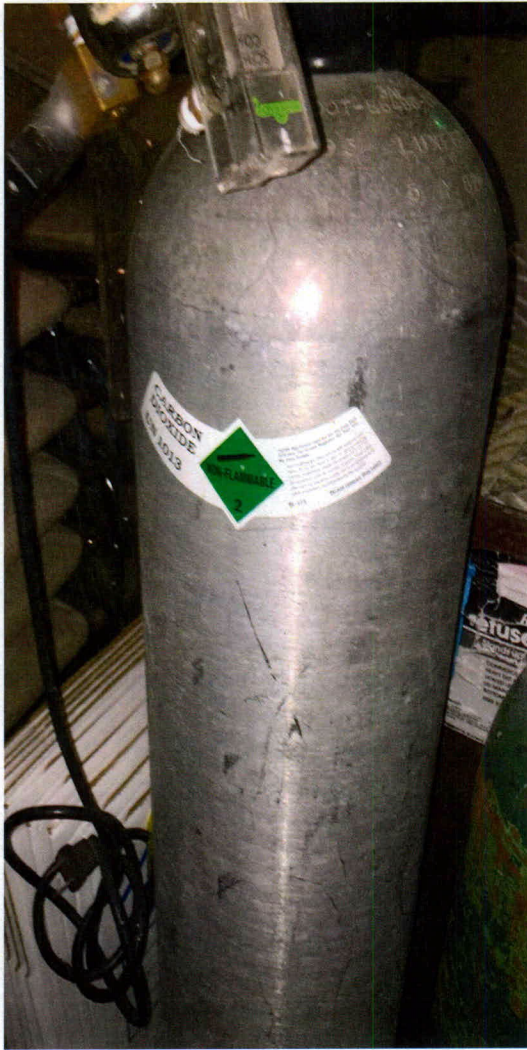
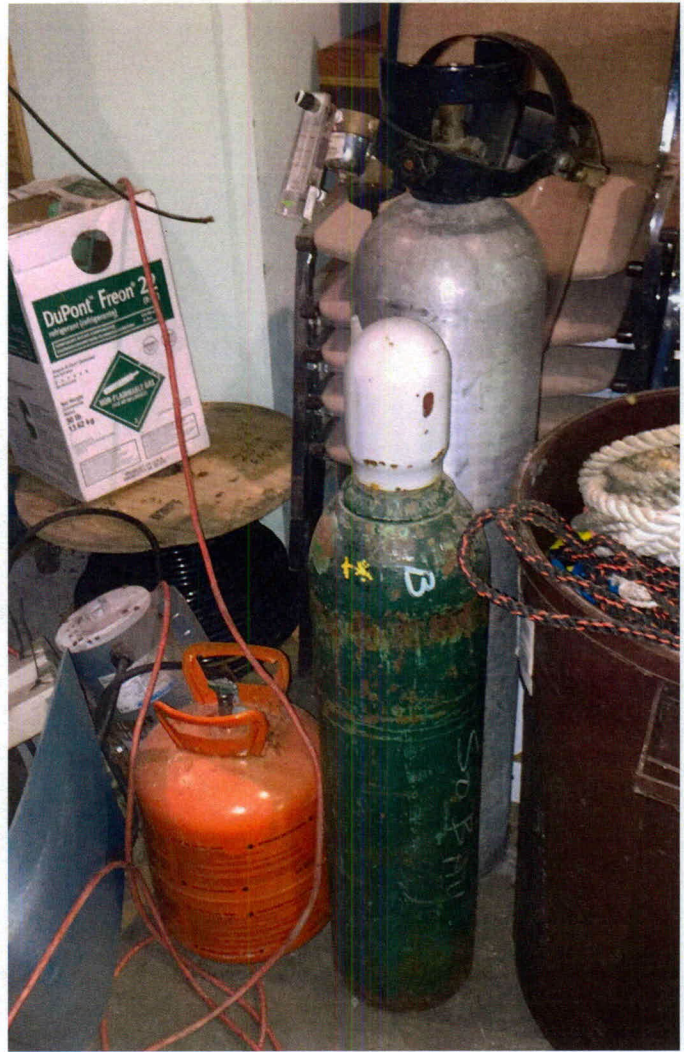
Unmarked cylinders of compressed gas were improperly stored without being secured. (See photos 16-17).

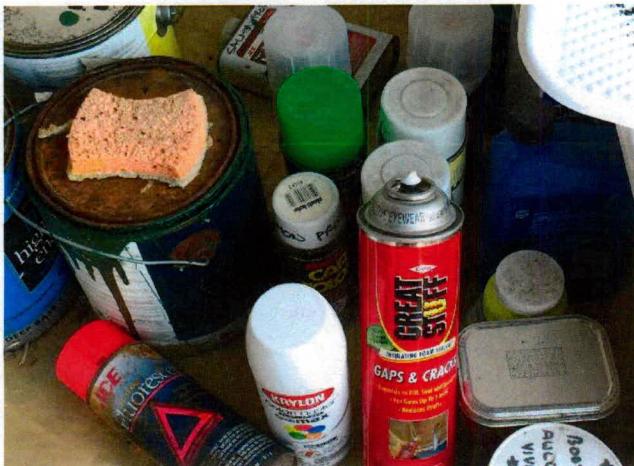
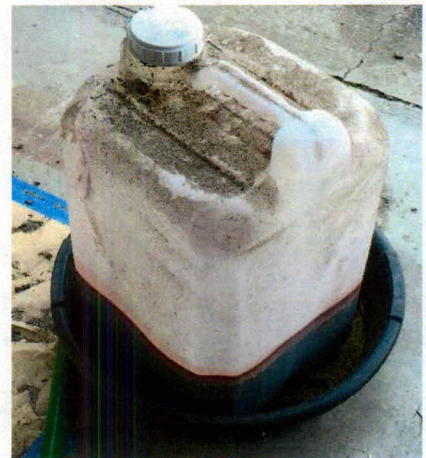
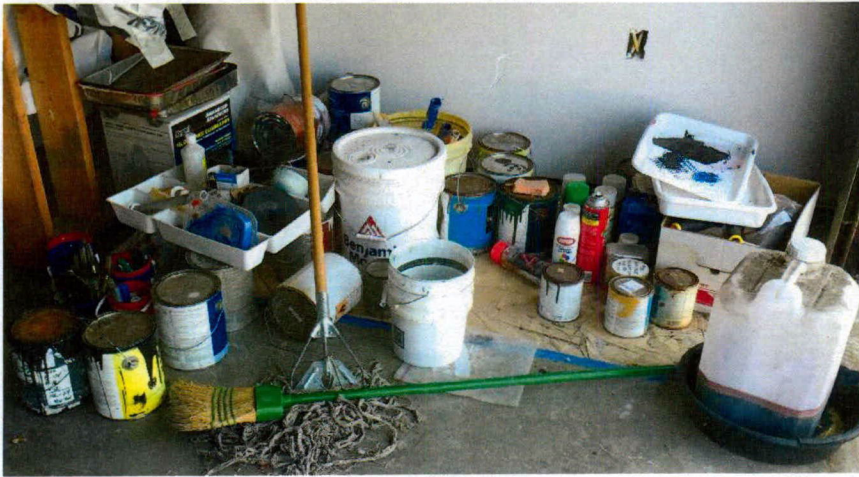
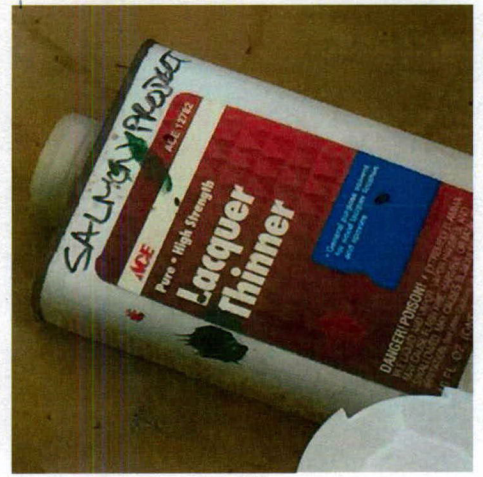
Cans of motor oil and other flammable lubricants were noted in unmarked boxes, not properly stored, and representing a fire hazard given the volume of combustible material in scattered throughout the premises. (See photos 18-21).

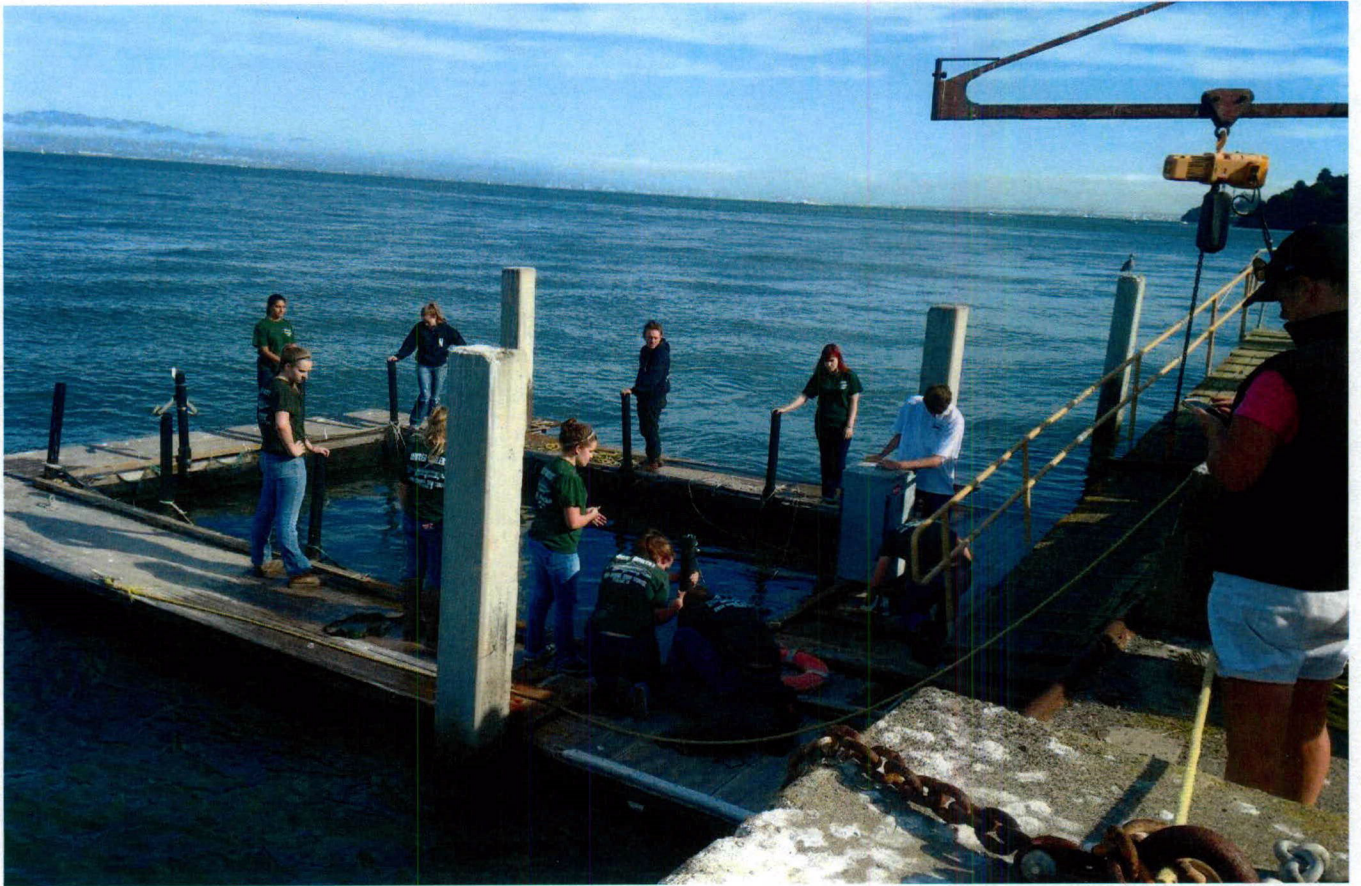
22

Students are allowed around the edges of the floating platform to undo the netting to release the salmon. (See photo 22).

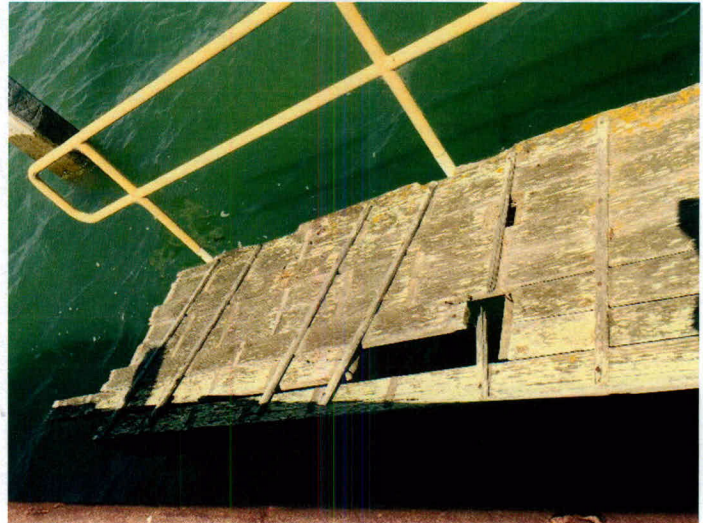
24

- The walkway to the floating platform is weathered and unusable. It has holes big enough for a leg to go through. It needs replacement before any public is allowed on the water. (See photo 24).
- Life preserves are not worn by students on the floating platform or at the seawall as required by RTC. (See photos 25 and 26).
- There is no evidence that students on the water are capable swimmers.
- A rescue boat is not in evidence.
- Certified lifeguards are not in evidence.
- There is a strong along shore current that would quickly take someone in the water away from the seawall.
- Rescue buoys are in place, some were inaccessible.
- The public, including toddlers, are kept away from the seawall edge by a single rope line. Under the crowded circumstances this is insufficient to prevent a drowning. (See photo 27).

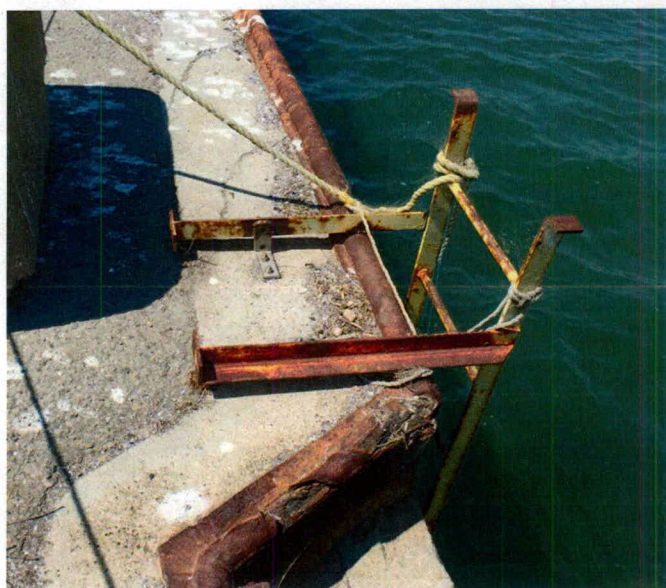
30

- While vehicle access to the water is controlled by a locked gate, foot access to the water is not prevented. The boat ramp's locked vehicle gate will not prevent toddlers from getting to the water's edge where they are at risk from rogue waves and strong cross currents leading away from shore at the boat ramp. (See photos 28 and 29).
- Vehicles launching or recovering boats in the early morning often have bright sunlight in their rear view as they back up to the water's edge impairing visibility. A flagman should be used to facilitate this activity.
- Using the ladder on the seawall to add passengers to boats already launched is a high risk activity that should be prohibited. (See photo 30).
