Building 86

Building Code Evaluation for Building 86
Romberg Tiburon Center
Tiburon, CA 94920

Prepared on: August 3, 2015

Inspection Date: July 29, 2015

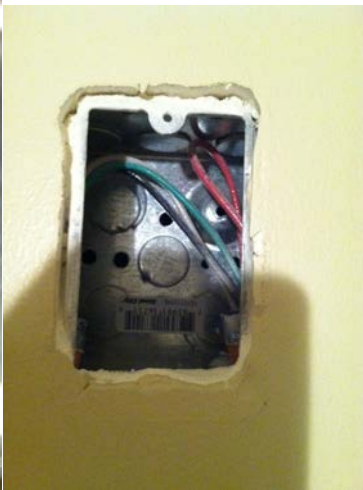
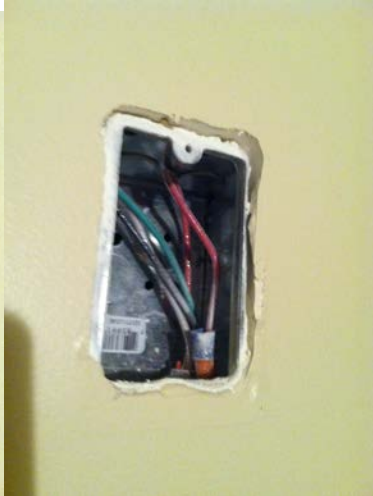
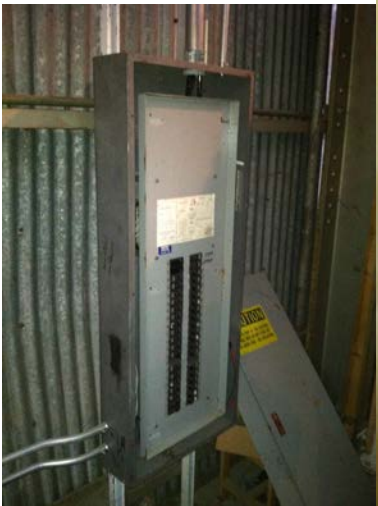
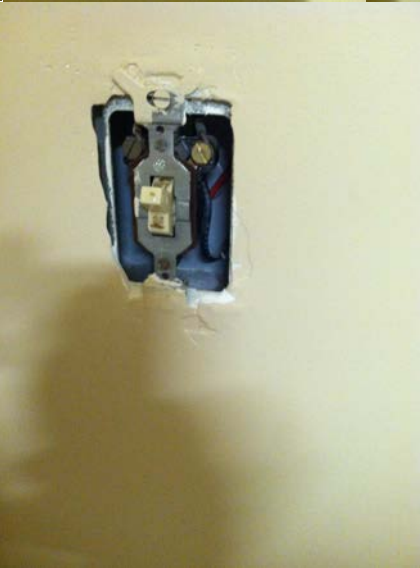
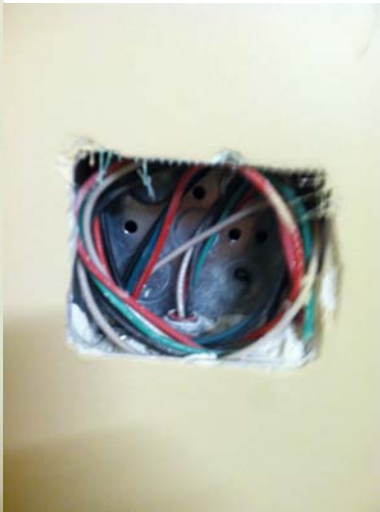
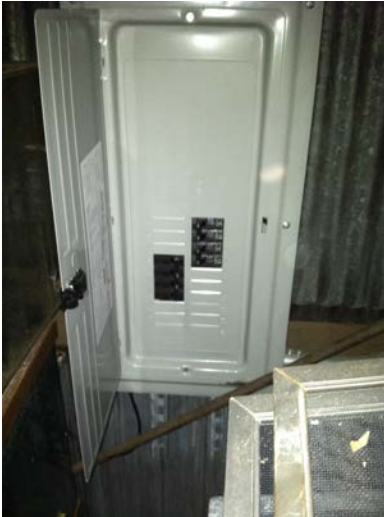
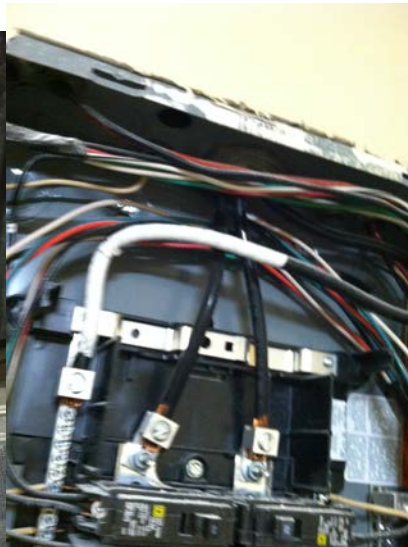
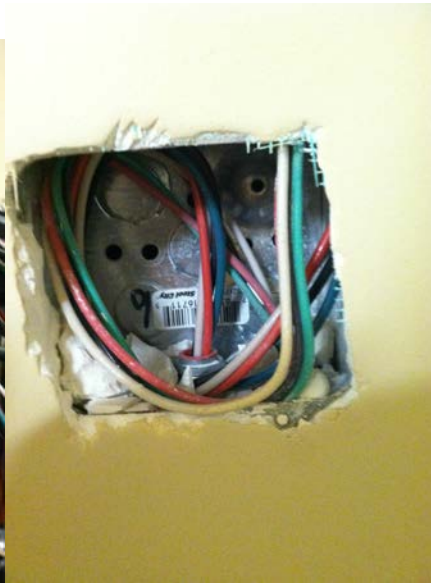
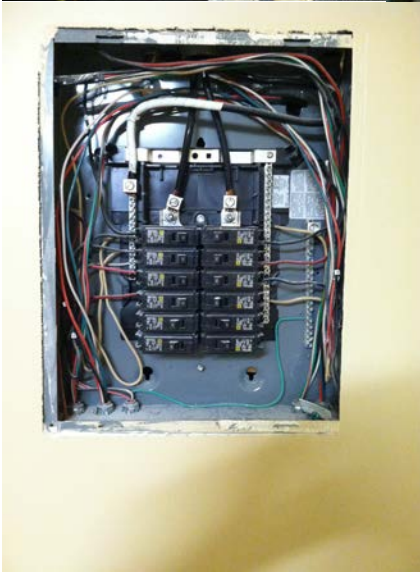
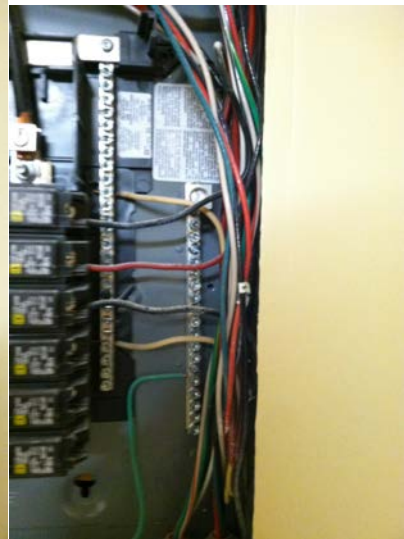
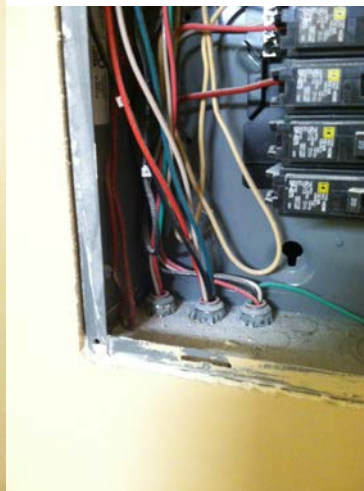
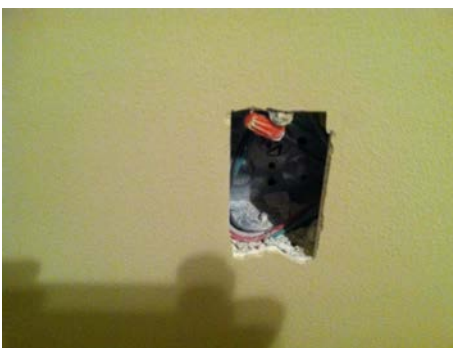
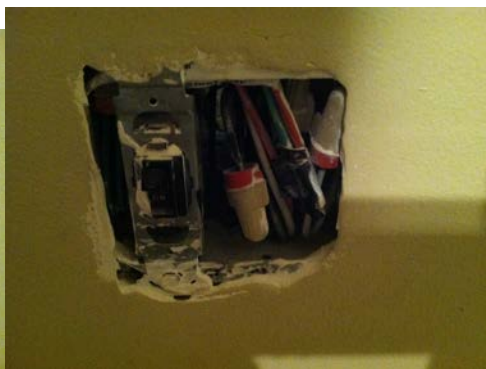
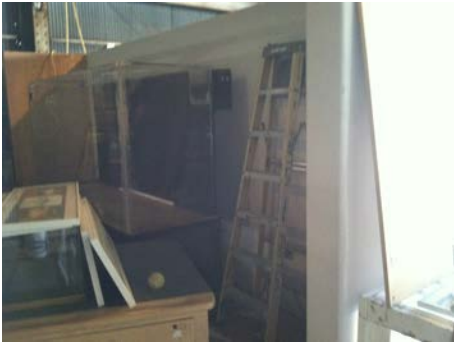
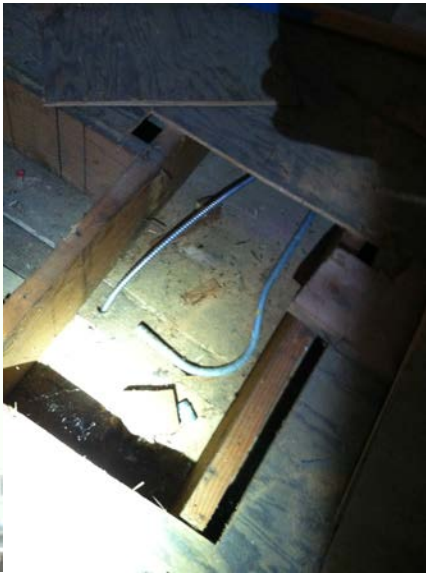
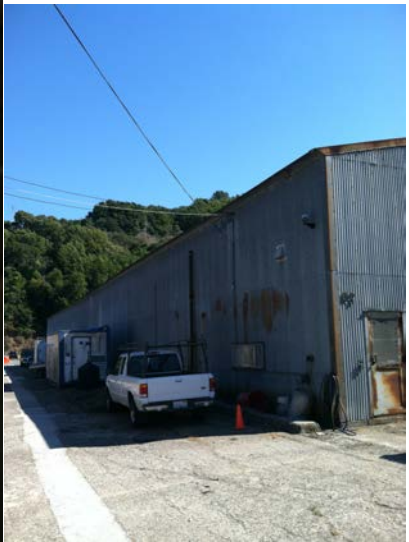
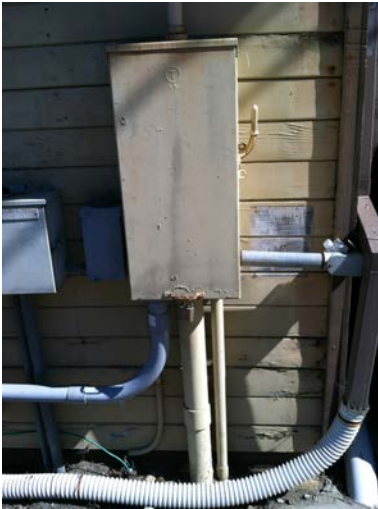
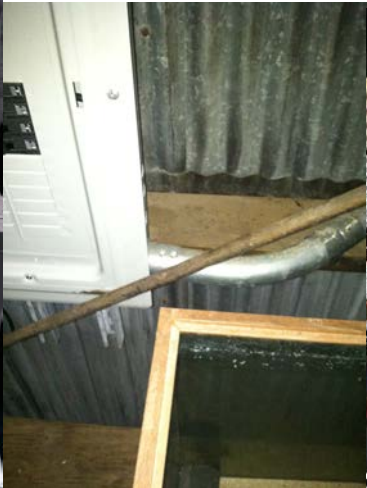
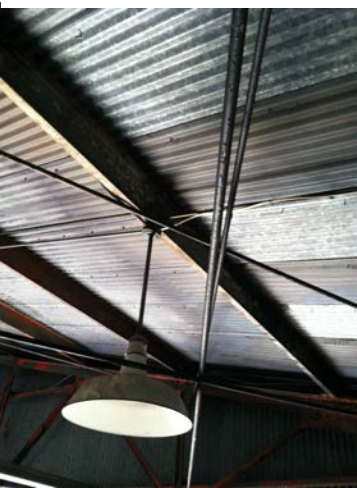
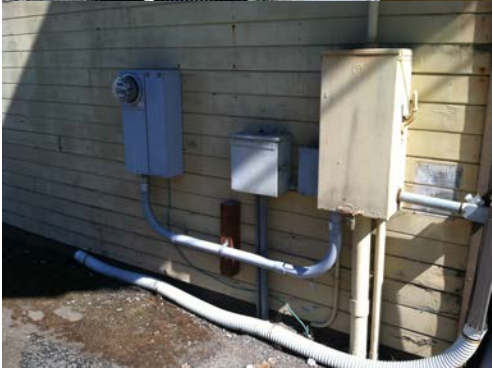
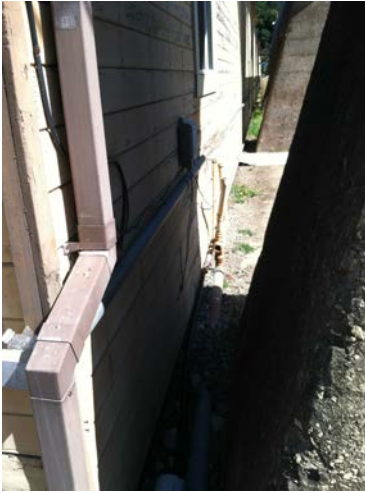
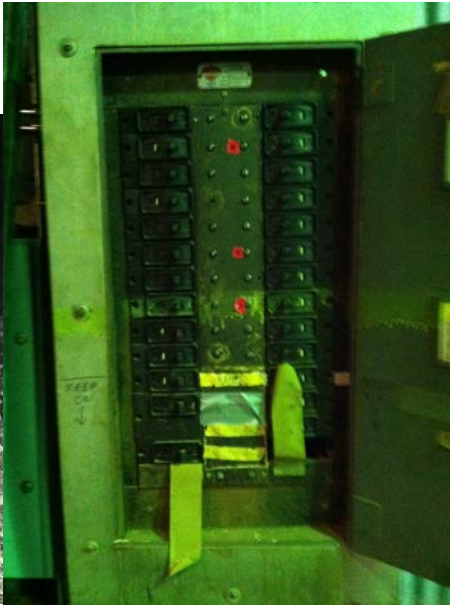
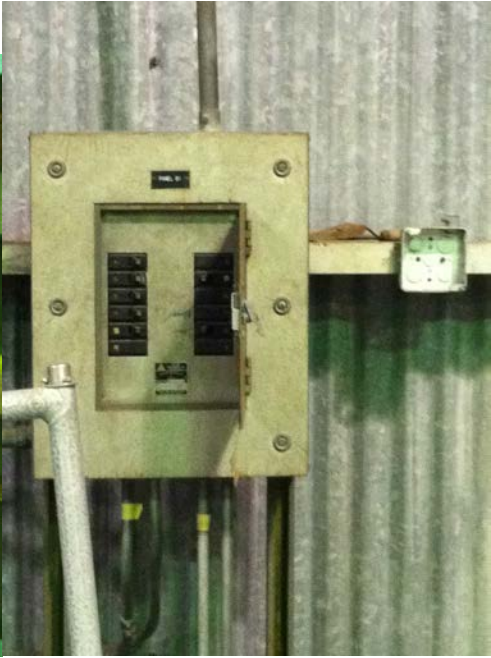
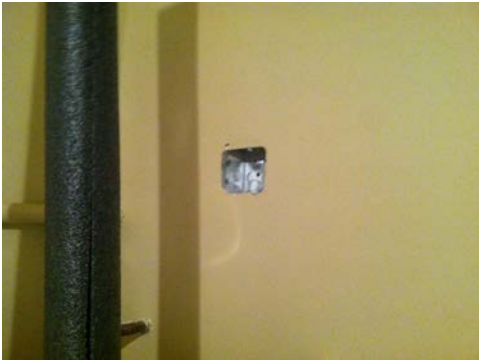
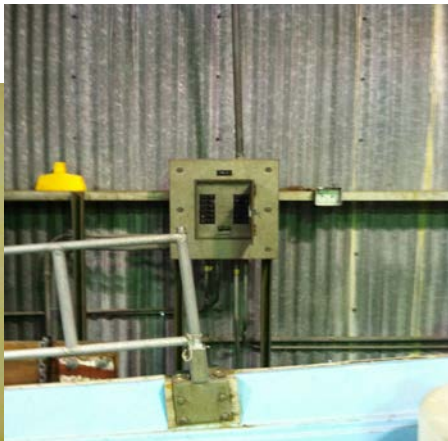
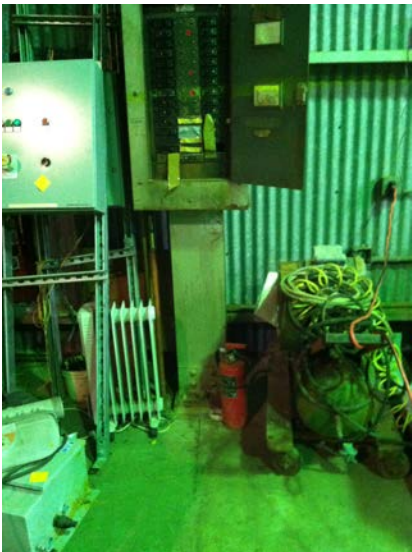
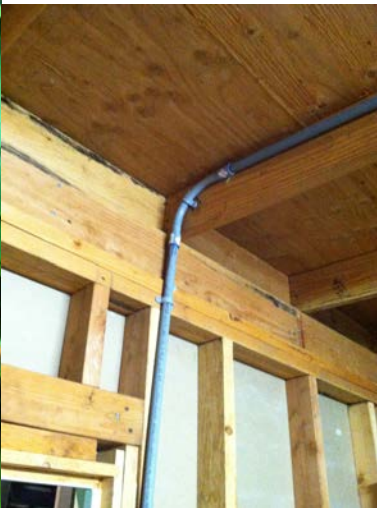
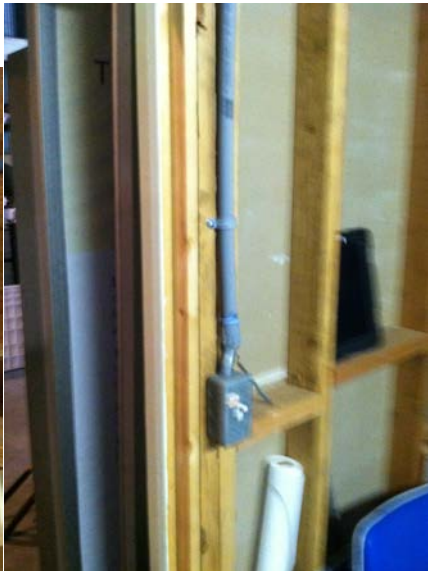
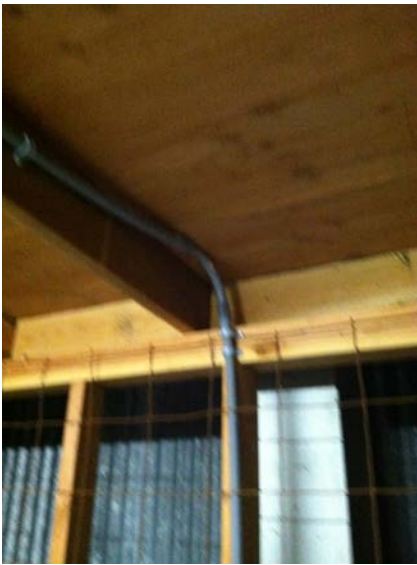
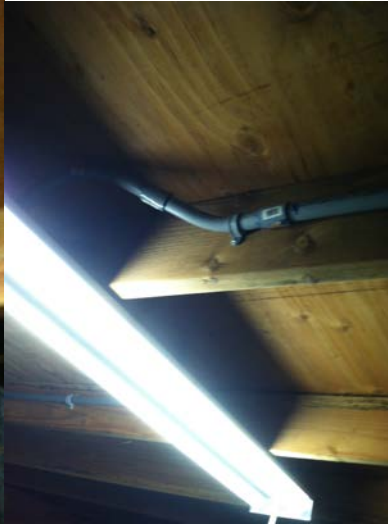
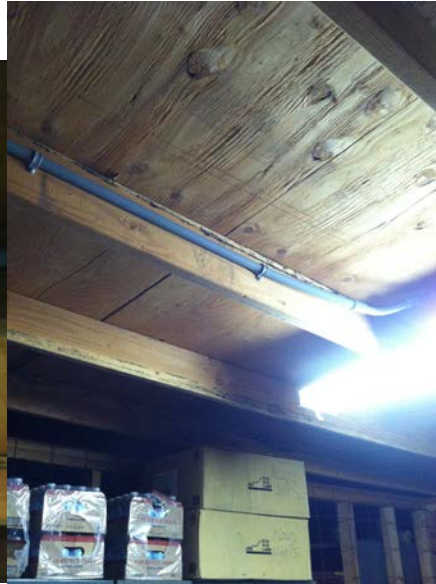
Code References violated by the electrical installation are multiple. Many violations identified have multiple codes that can be referenced in the same location. Below is a narrative of some issues that are in violation of the Cal Electrical Code. A summary of the defects indicates that the system should be removed, designed by an electrical engineer, installed with proper wire size and installation requirements, and said design is to include the interface with existing ungrounded electrical systems that demonstrate aged deterioration, insufficiency of installation and potential failure.

1. Junction boxes are unsafe/not safed off. 110.27
2. There are multiple electrical panels around the structure. One such panel is located to the right just past the newly constructed walls on the west wall exterior see picture. This panel seems to be a sub distribution panel pulling electricity from a newly installed main distribution panel above the existing office space. This panel is not properly bonded or grounded, article 250 et al,

12. Electrical boxes are improperly supported or unsupported completely. 110.13
13. Existing electrical system has no ground and is not properly bonded Article 200.3, 250, et al.

23. Romex wiring installed in violation of 334.
