## SAN FRANCISCO STATE UNIVERSITY

### MEMORANDUM

SUBJECT: TSI Safety Assessment at RTC

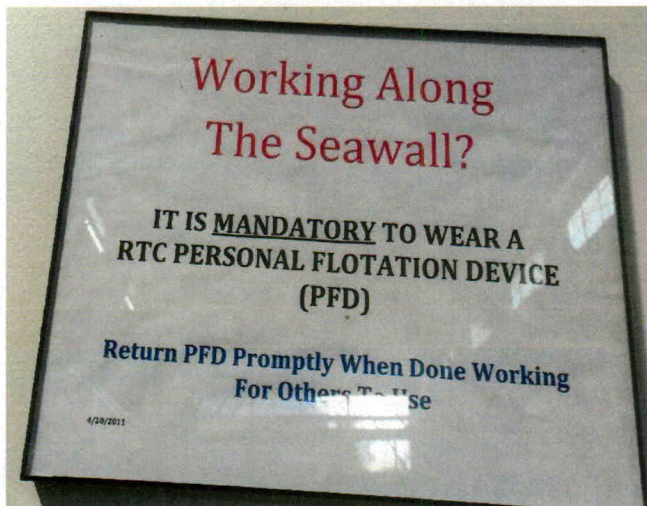
24

- The walkway to the floating platform is weathered and unusable. It has holes big enough for a leg to go through. It needs replacement before any public is allowed on the water. (See photo 24).
- Life preserves are not worn by students on the floating platform or at the seawall as required by RTC. (See photos 25 and 26).
- There is no evidence that students on the water are capable swimmers.
- A rescue boat is not in evidence.
- Certified lifeguards are not in evidence.
- There is a strong along shore current that would quickly take someone in the water away from the seawall.
- Rescue buoys are in place, some were inaccessible.
- The public, including toddlers, are kept away from the seawall edge by a single rope line. Under the crowded circumstances this is insufficient to prevent a drowning. (See photo 27).
